ASBESTOS INSPECTION REPORT

**4775 Towne Square Boulevard
Suitland, MD 20746**

Report Date: **March 3, 2021**

OSE Project Number: 21-1040A-ACM

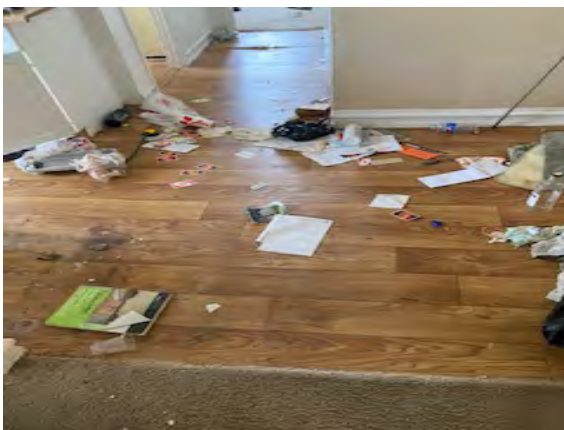
Photo #3:	Typical Wood Look Alike Linoleum Unit 9 Sample Set #20 – Non-ACM
-----------	--

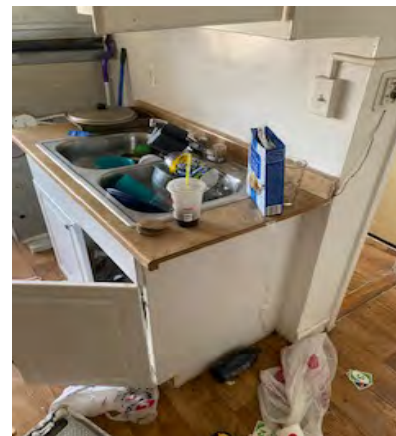
Photo #4:	Typical Counter Caulk Kitchens Sample Set #14 – Non-ACM
-----------	---

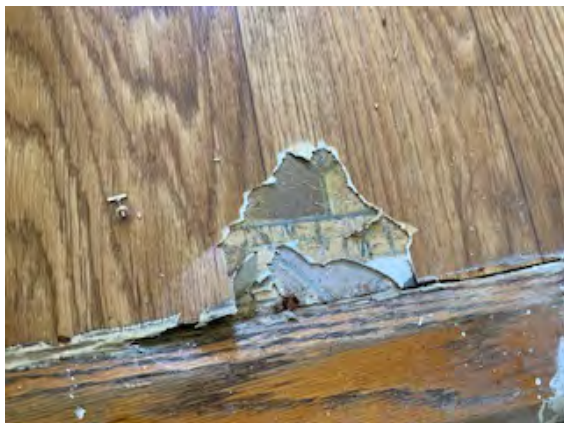
Photo #5:	Typical 12" Colored Floor Tile & Glue Bathrooms Sample Set #21 – Non-ACMs
-----------	---

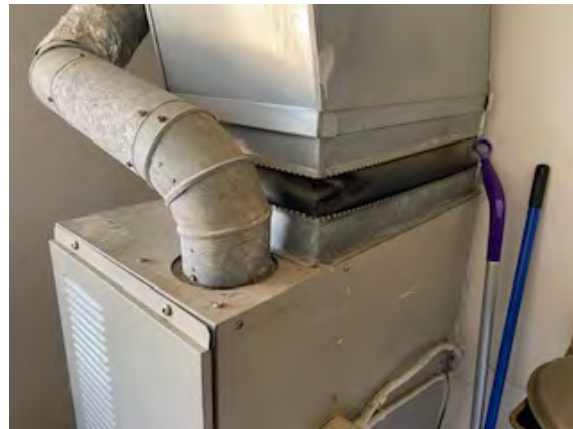
Photo #6:	Typical Duct Vibration Damper Kitchen HVAC Units Sample Set #12 - Non-ACM
-----------	---

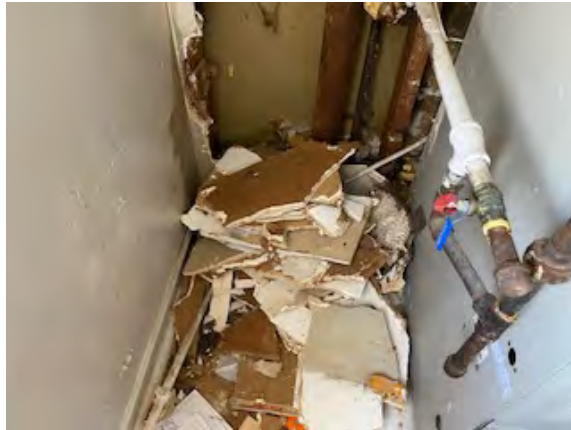
Photo #7:	Typical Drywall Behind Plaster Wall Systems Sample Set #2 – Non-ACM
-----------	--

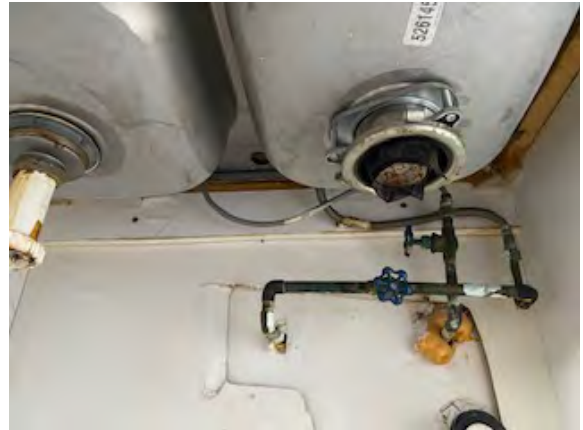
Photo #8:	No Sink Undercoat/Insulation Most Units
-----------	--

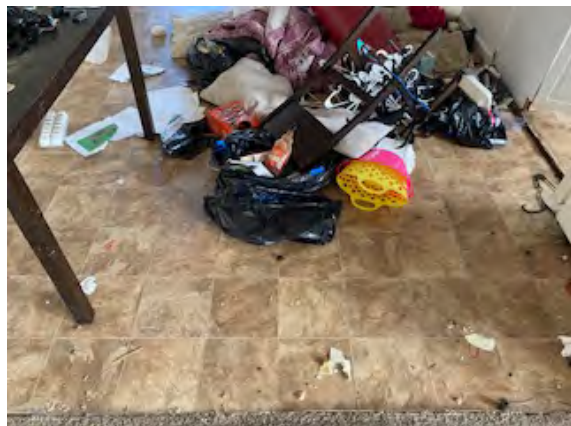
Photo #9:	Brown Square Pattern Linoleum & Glue Unit 10 Sample Set #22 – Non-ACMs
-----------	--

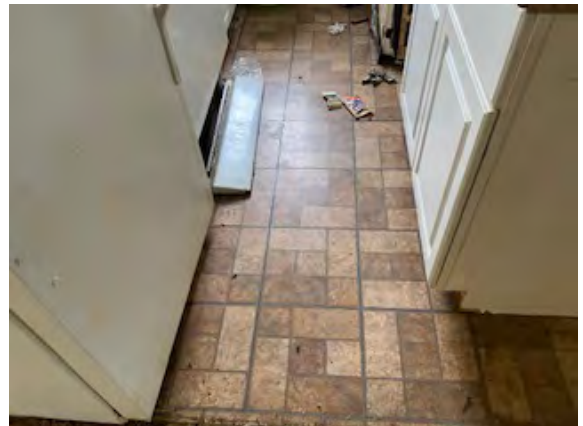
Photo #10:	12" Vinyl Floor Tiles & Glues – 3 Layers Unit 11 Sample Sets #24, 25, & 26 - Non-ACMs
------------	---

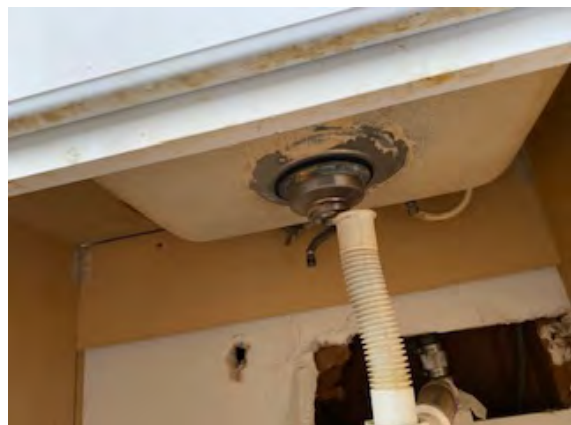
Photo #11:	White Sink Undercoat/Insulation Unit 11 - Kitchen Sample Set #10 – Non-ACM
------------	--

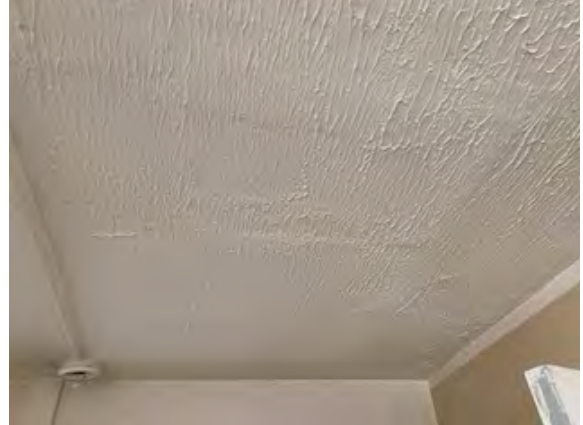
Photo #12:	Typical Textured Ceiling 2 nd and 3 rd Floor Units Sample Set #9 – Non-ACM
------------	--

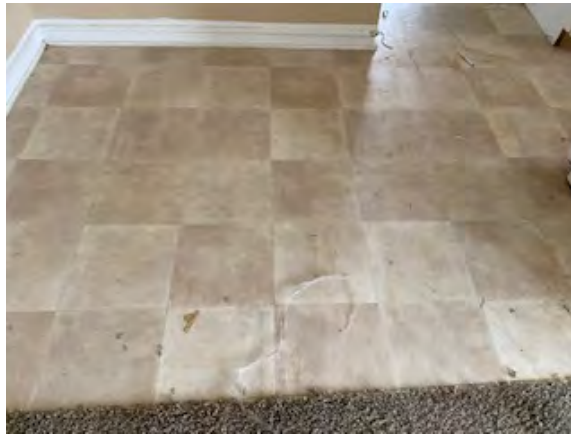
Photo #13:	12" White Square Pattern Linoleum Unit 11 Sample Set #23 – Non-ACM
------------	--

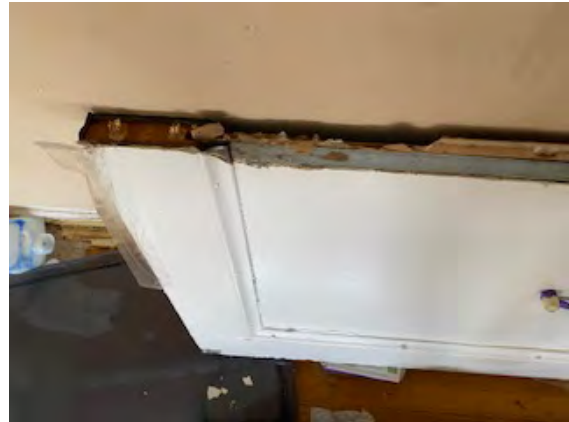
Photo #14:	Cross Cut of Typical Fire Door No Suspected ACM
------------	--

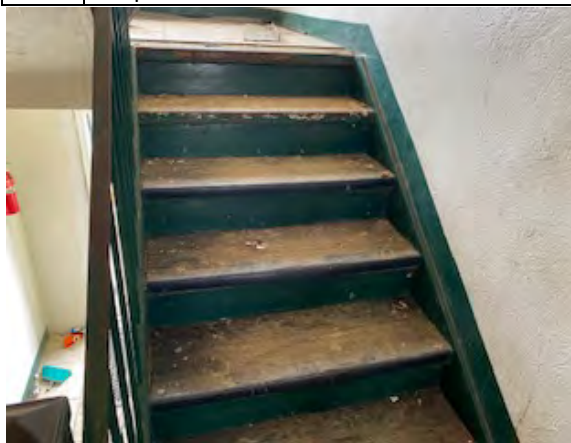
Photo #15:	Vinyl Stair Treads & Glue Stairwell Sample Set #16 – Non-ACMs
------------	---

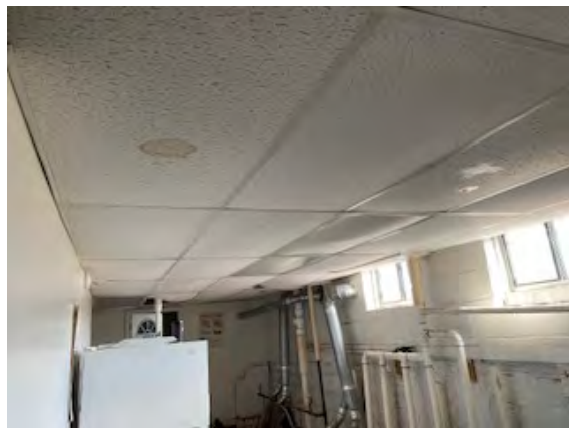
Photo #16:	2'x4' Pinhole Ceiling Tile Laundry Room Sample Set #5 – Non-ACM
------------	---

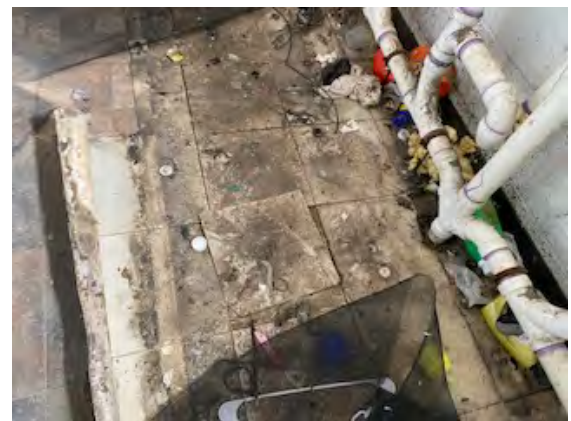
Photo #17:	12" Brown Pattern Linoleum & 12" White Floor Tile & Glues – Laundry Room Sample Sets #18 & #19 – Non-ACMs
------------	---

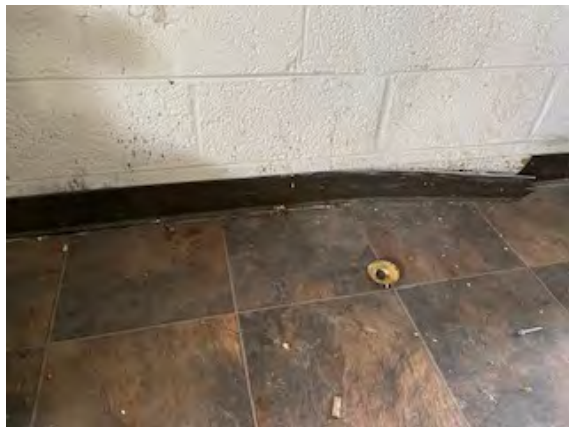
Photo #18:	4" Brown Covebase & Glue Laundry Room Sample Set #17 – Non-ACMs
------------	---

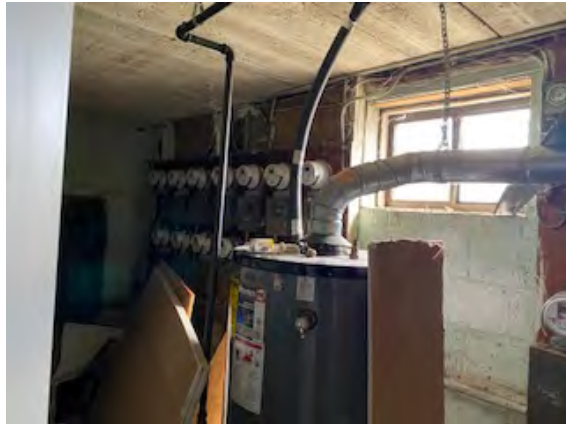
Photo #19:	Storage/Meter Rooms No Suspected ACM
------------	---

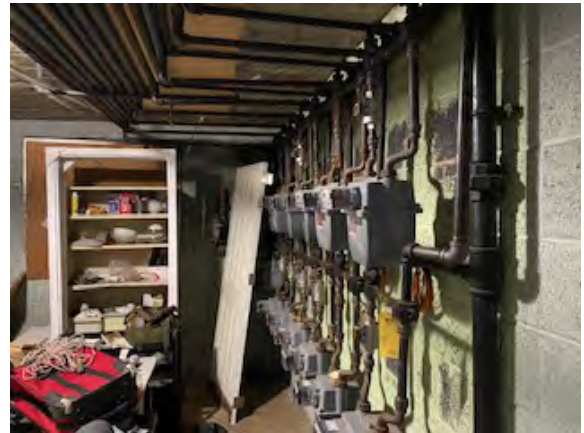
Photo #20:	Storage/Meter Rooms No Suspected ACM
------------	---

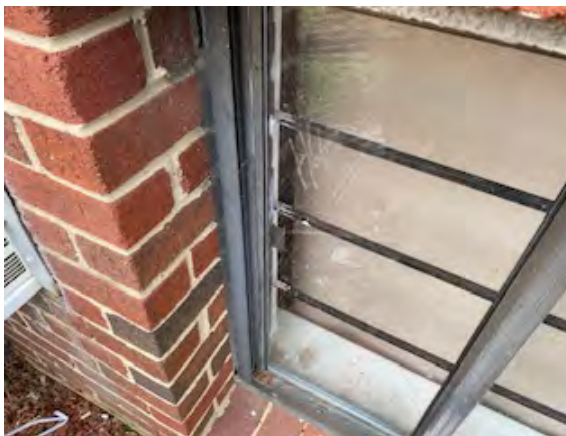
4775 Towne Square Blvd – Suitland, MD 20746					
Material	Location	Percentage/ Type*	Material Condition	Approx. Quantity	NESHAP Category
Exterior Window Caulk	Windows Throughout Building	3% Chrysotile	Good	102 Windows @ 12 Linear Feet Each	CAT II

Results of analysis confirmed asbestos was identified in concentrations greater than 1% within one of the bulk samples collected. The identified asbestos-containing material was found to be in good condition at the time of the inspection. The materials that are or may become friable during demolition or renovation must be removed prior to their disturbance using OSHA Class II abatement procedures.

Photo #21:	Typical Exterior Window Caulk Sample Set #11 3% Chrysotile Asbestos
------------	---

Abatement of ACM should be performed by an MDE accredited Asbestos Abatement Firm employing MDE accredited Asbestos Abatement Supervisors and Workers, with a certified asbestos supervisor onsite at all times during asbestos abatement activities.

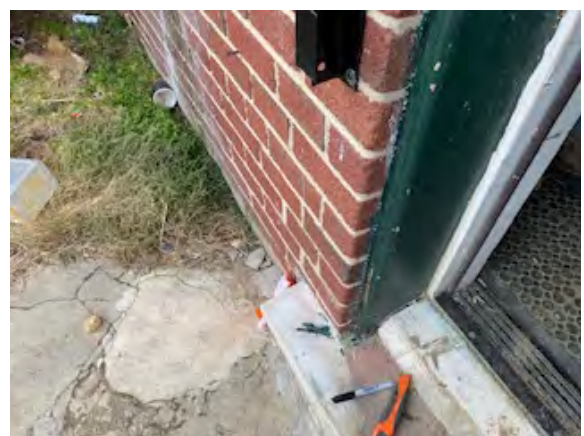
Photo #22:	Exterior Door Caulk Sample Set #15 – Non-ACM
------------	---

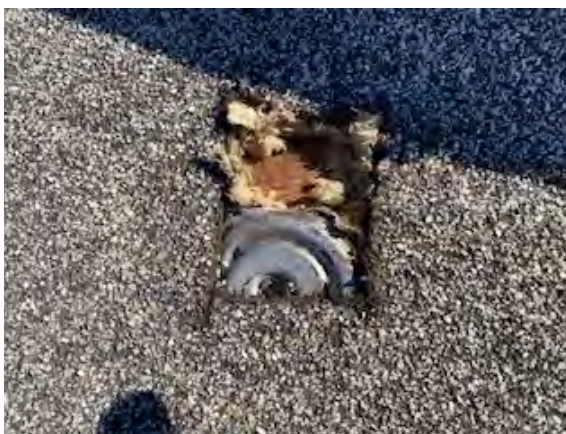
Photo #23:	Rollled Asphalt Sheeting & Insulation Main Roof Sample Sets #7 & #8 – Non-ACMs
------------	--

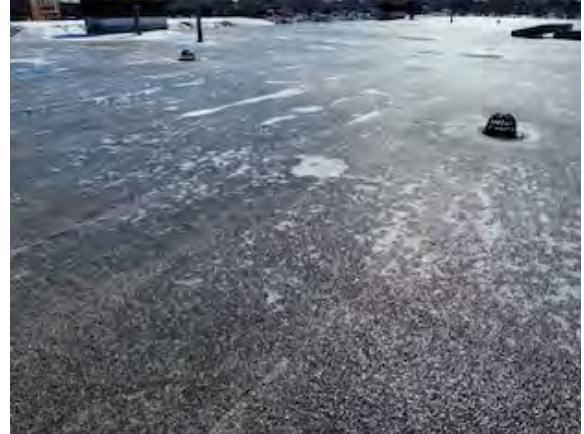
Photo #24:	Flashing Caulk Roof Sample Set #27 – Non-ACM
------------	--

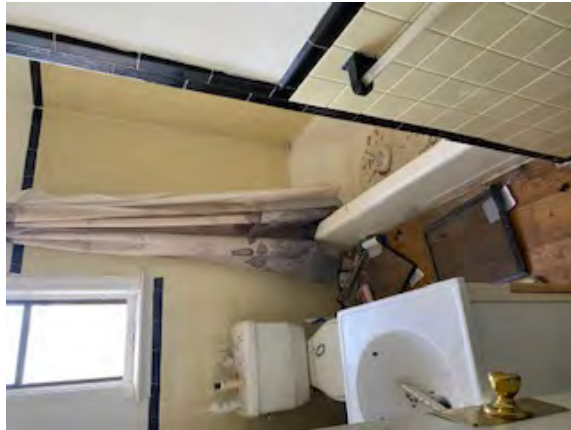
Photo #25:	Typical Interior Window Caulk Sample Set #13 – Non-ACM
------------	---

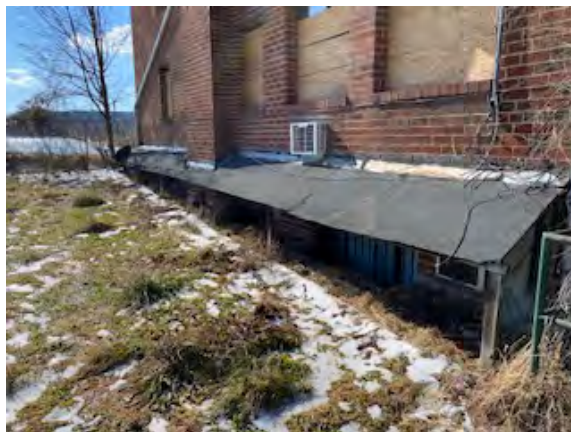
Photo #27:	Asphalt Sheeting Small Rear Roof Sample Set #6 – Non-ACM
------------	--

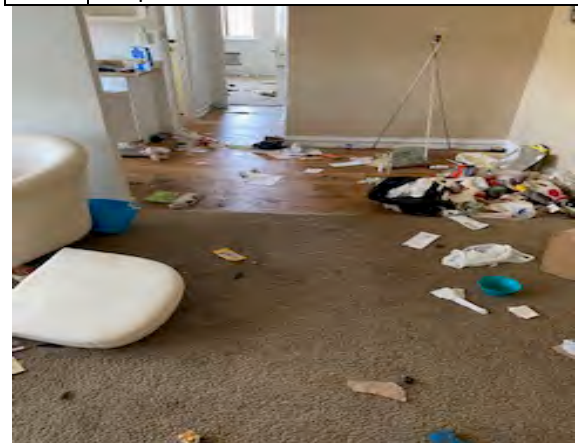
Photo #28:	Typical Plaster Walls Throughout Building Sample Set #1 – Non-ACM
------------	---

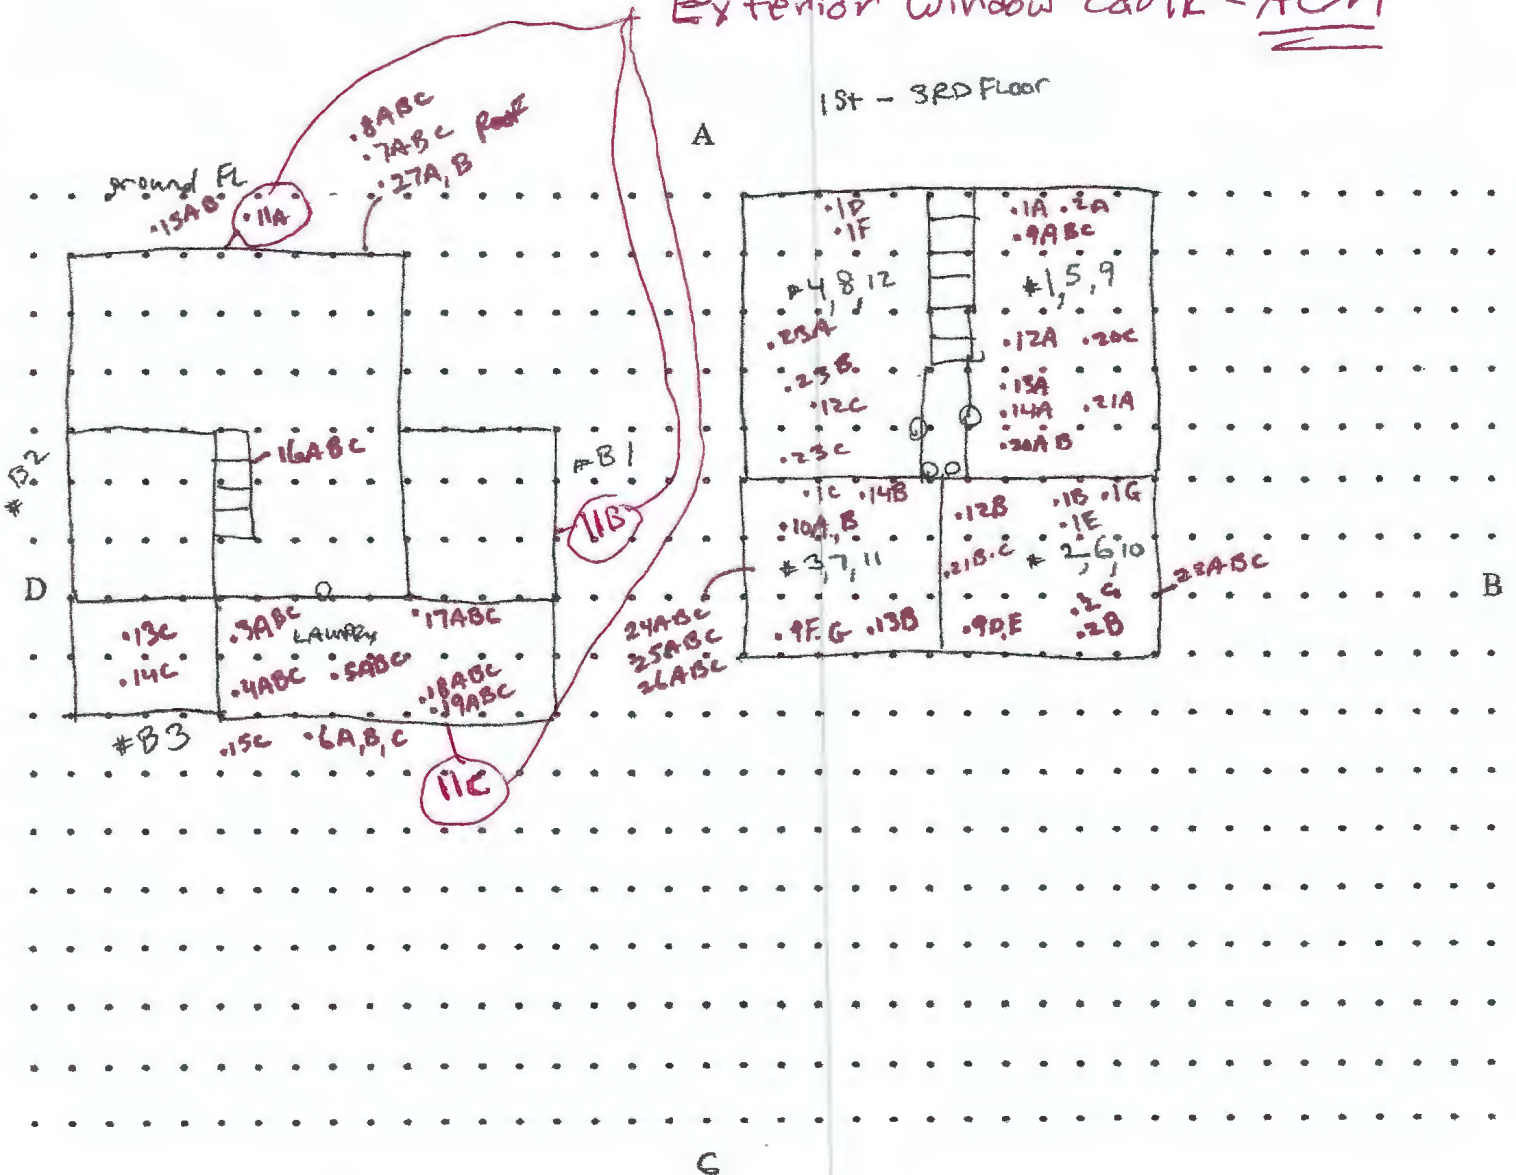
Exterior Window Caulk - ACM
