ASBESTOS INSPECTION REPORT

**4785 Towne Square Boulevard
Suitland, MD 20746**

Inspection Dates: **February 19 & 20, 2021**

OSE Project Number: 21-1040B-ACM

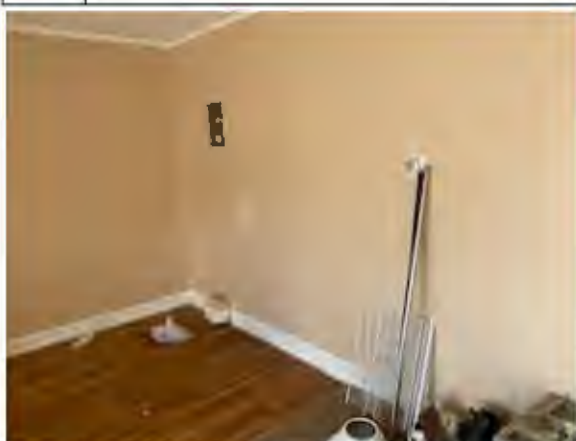
Photo #3: Typical Plaster Walls – 2 Layers Throughout Building
Sample Set #1 – Non-ACMs

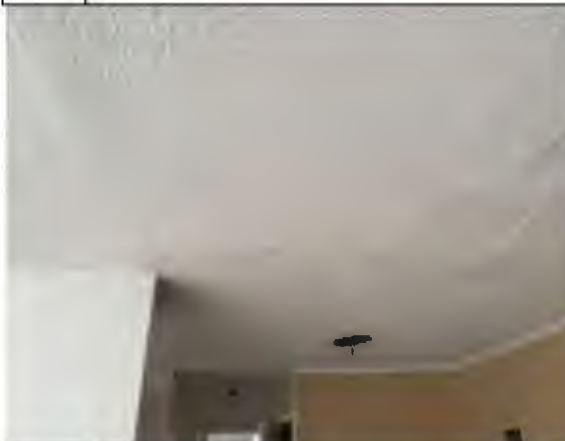
Photo #4: Typical Thin Textured Ceiling
Sporadic Locations Throughout
Sample Set #3 – Non-ACM

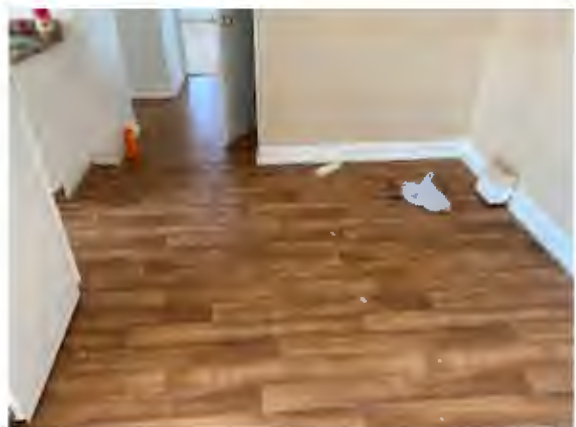
Photo #5: Wood Look Alike Linoleum
Unit 11
Sample Set #21 – Non-

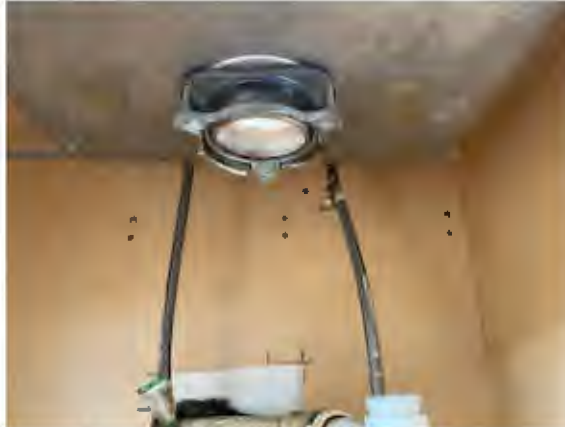
Photo #6: Typical Unit
No Sink Undercoating/Insulation

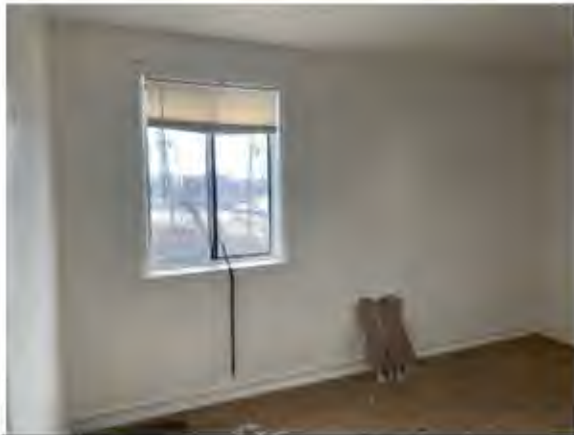
Photo #7:	Typical Interior Window Caulk Throughout Building Sample Set #12 – Non-ACM
-----------	---

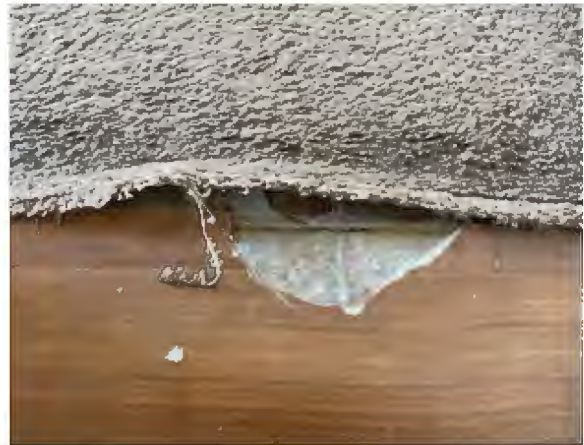
Photo #8:	Square Stone Pattern Linoleum Unit 11 – 2 nd Layer Sample Set #22 – Non-ACM
-----------	---

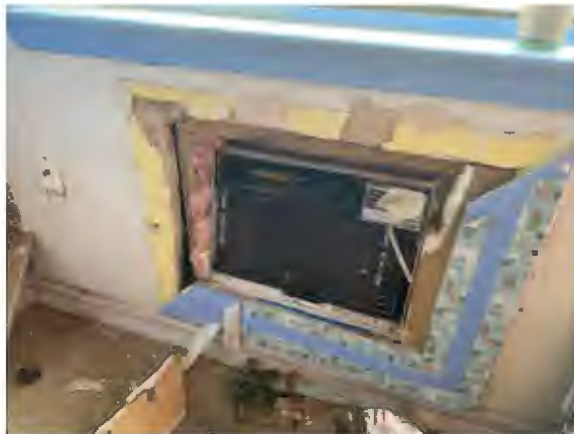
Photo #9:	Typical Drywall Behind Plaster Throughout Building Sample Set #4 – Non-ACMs
-----------	--

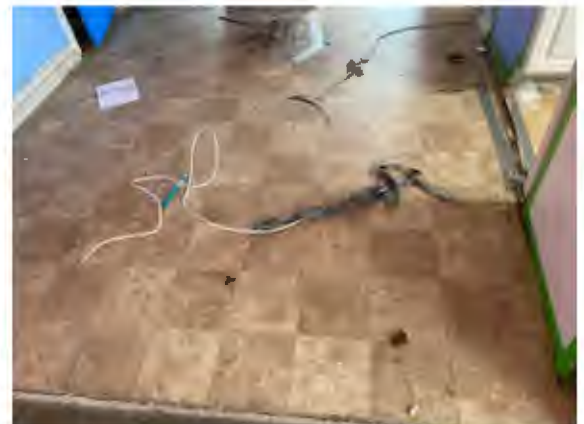
Photo #10:	9" Beige Stone Pattern Linoleum & Mastic Unit 12 Sample Set #16 – Non-ACMs
------------	---

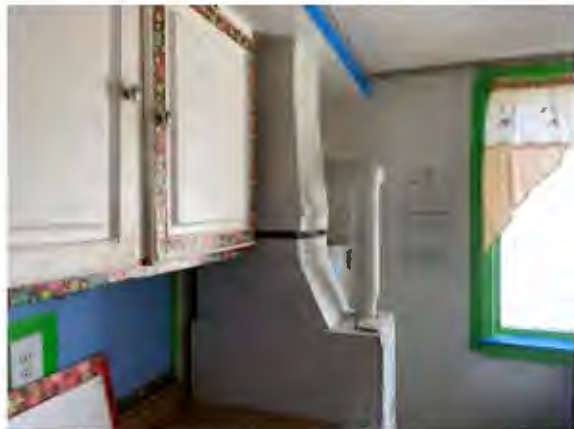
Photo #11:	Typical Vibration Damper Kitchens Sample Set #10 – Non-ACMs
------------	--

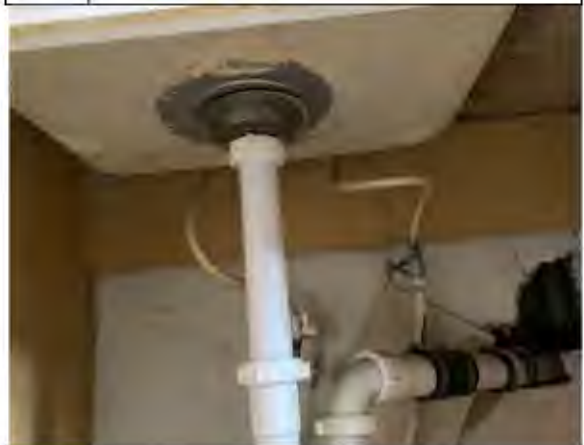
Photo #12:	White Sink Undercoat/Insulation Sporadic Locations Sample Set #15 – Non-ACM
------------	--

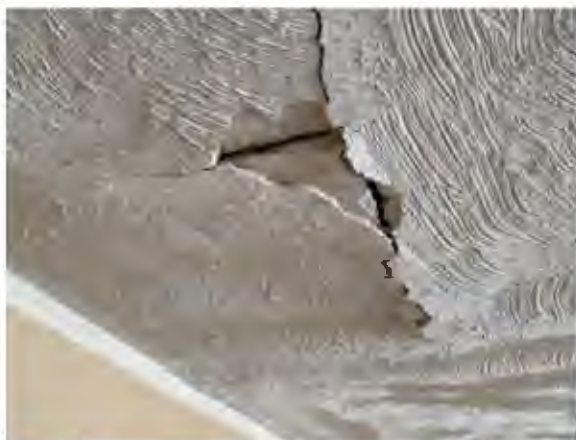
Photo #13:	Thick Textured Ceiling Unit Ceilings Sample Set 2 – Non-ACM
------------	---

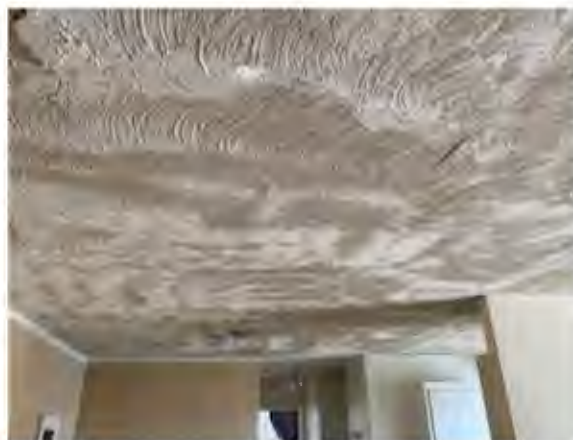
Photo #14:	Thick Textured Ceiling Unit Ceilings Sample Set 2 – Non-ACM
------------	---

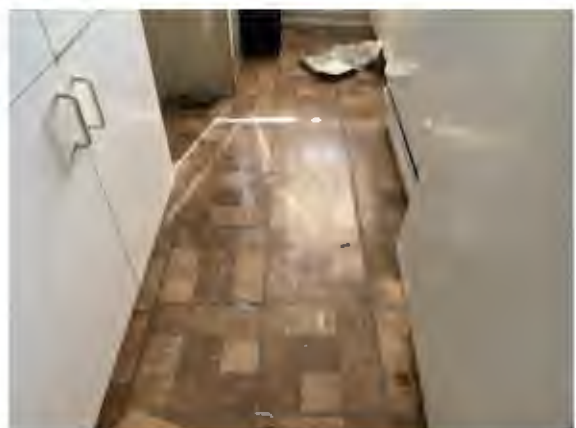
Photo #15:	Small & Big Brick Pattern Linoleum & Mastic Unit 8 Sample Set #17 – Non-ACMs
------------	--

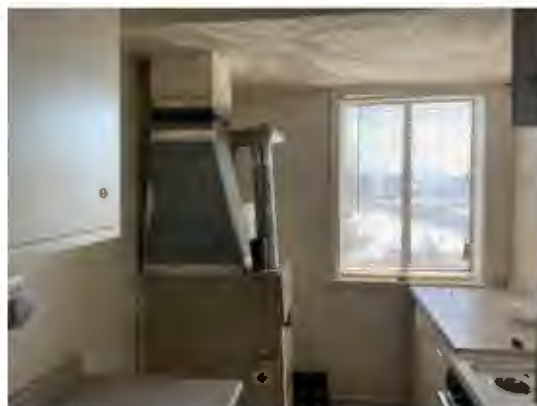
Photo #16:	Typical Counter Caulk Kitchens Sample Set #9 – Non-ACM
------------	--

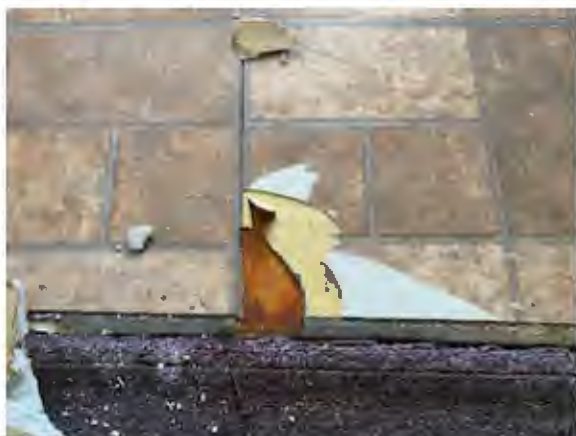
Photo #17:	12" Brick Pattern Floor Tile, 12x12 White Floor Tile & Mastics – Unit 10 Kitchen Sample Sets #19 & 20 – Non-ACMs
------------	--

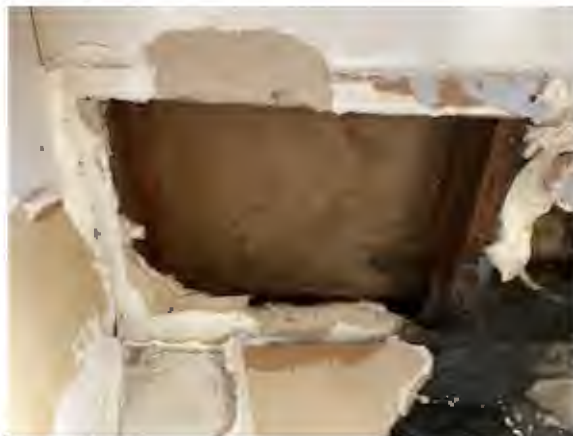
Photo #18:	Typical Drywall Behind Plaster Throughout Building Sample Set #4 – Non-ACM
------------	--

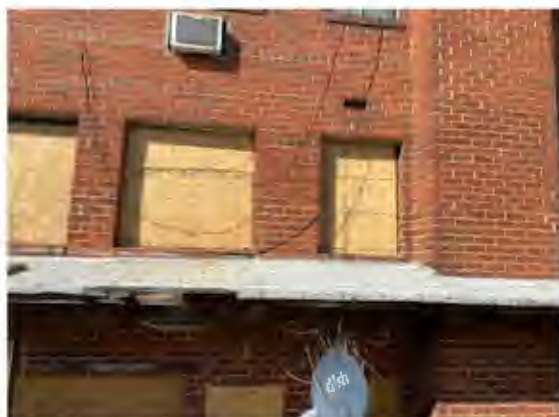
Photo #19: Asphalt Roof Shingles & Paper
Rear Small Roof
Sample Sets #6& #7 – Non-ACMs

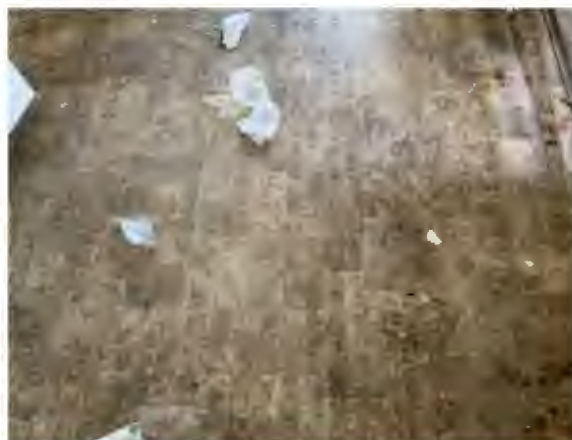
Photo #20: Rectangle Stone Pattern Linoleum & Mastic
Unit 9
Sample Set #18 – Non-ACMs

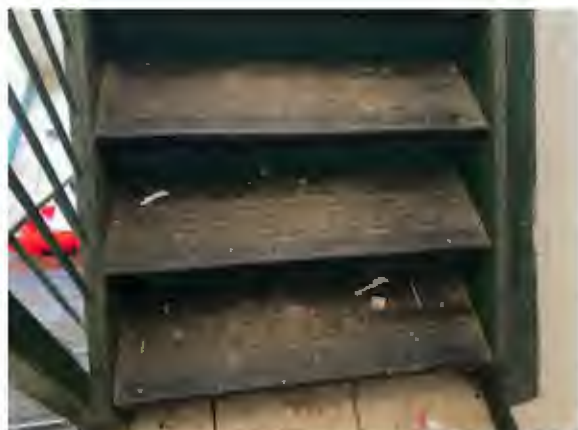
Photo #21: Vinyl Stair Tread and Glue
Hallway Stairs
Sample Set #14 – Non-ACMs

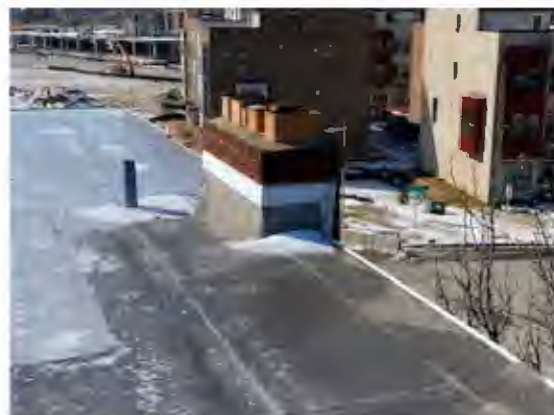
Photo #22: Roof Flashing Caulk
Main Roof
Sample Set #5 Non-ACM

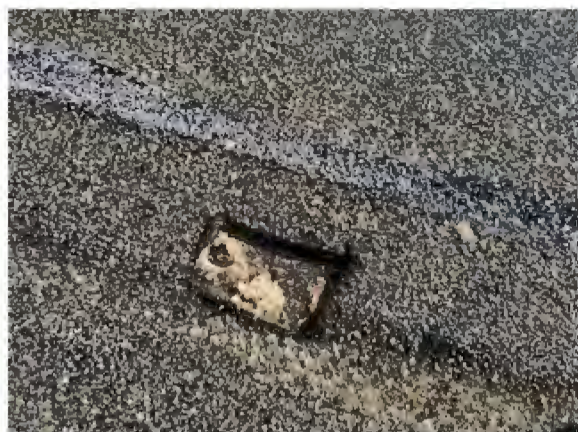
Photo #23: Rolled Asphalt Sheeting
Main Roof
Sample Set #8 – Non-ACM

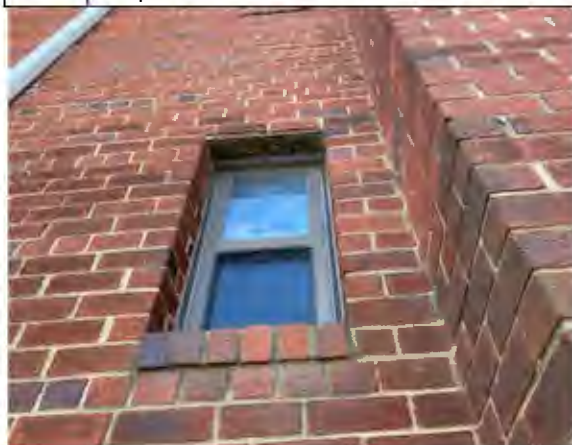
4785 Towne Square Blvd – Suitland, MD 20746					
Material	Location	Percentage/ Type*	Material Condition	Approx. Quantity	NESHAP Category
Exterior Window Caulk	Windows Throughout Building	3% Chrysotile	Good	102 Windows @ 12 Linear Feet Each	CAT II

Results of analysis confirmed asbestos was identified in concentrations greater than 1% within one of the bulk samples collected. The identified asbestos-containing material was found to be in good condition at the time of the inspection. The materials that are or may become friable during demolition or renovation must be removed prior to their disturbance using OSHA Class II abatement procedures.

Photo #24: Typical Exterior Window Caulk
Throughout Property
Sample Set #11 – 3% Chrysotile Asbestos

Abatement of ACM should be performed by an MDE accredited Asbestos Abatement Firm employing MDE accredited Asbestos Abatement Supervisors and Workers, with a certified asbestos supervisor onsite at all times during asbestos abatement activities.

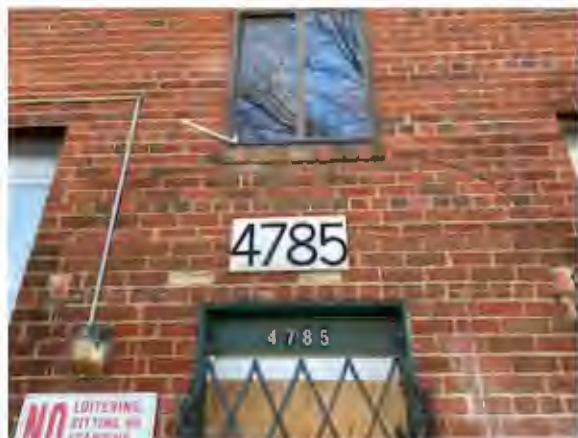
Photo	Exterior Door Caulk
#25:	Sample Set #13 – Non-ACM
