Re: **Lead Screening Inspection Report**
4785 Towne Square Boulevard
Suitland, MD 20746

One Source Environmental Project Number: 21-1040B-LBP

4785 Towne Square Blvd

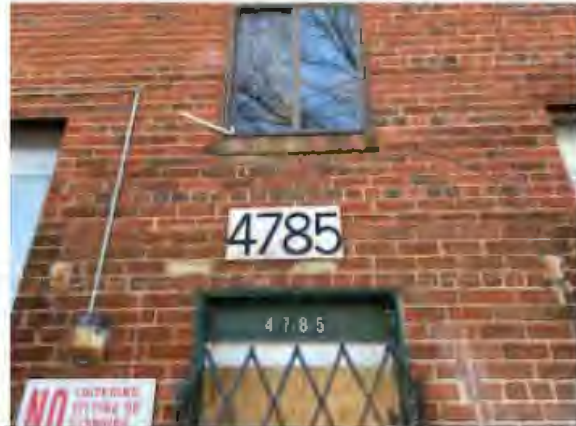
Location	Component(s)	Substrate	Color(s)
Exterior	Door Jambs	Wood	Green

Photo #2:	Front Door Jambs Intact LBP
-----------	--------------------------------

Any future demolition work should follow lead safe work practices outlined in 29 CFR 1926.62, the OSHA “Lead Exposure in Construction” Standard. All workers on the site should have a minimum of one day EPA renovator training.

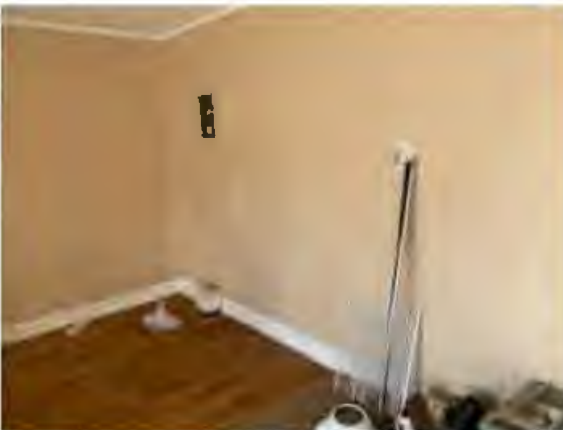
Photo #3:	Typical Living Room Components No LBP
-----------	--

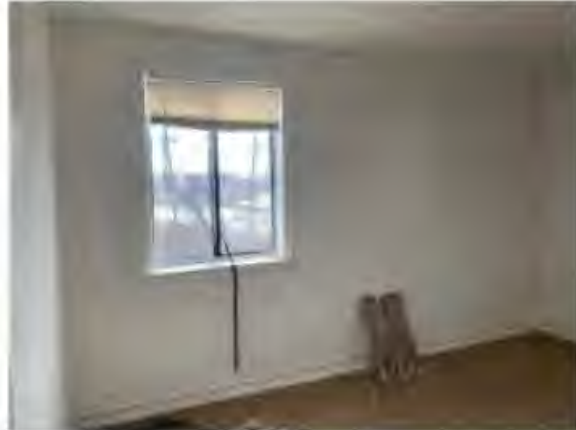
Photo #4:	Typical Bedroom Components No LBP
-----------	--------------------------------------

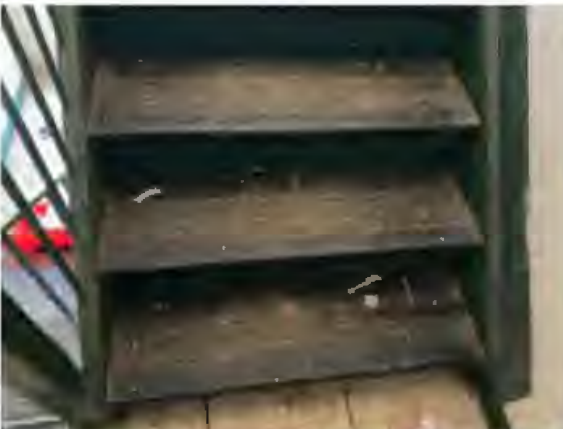
Photo #5:	Stair Components No LBP
-----------	----------------------------

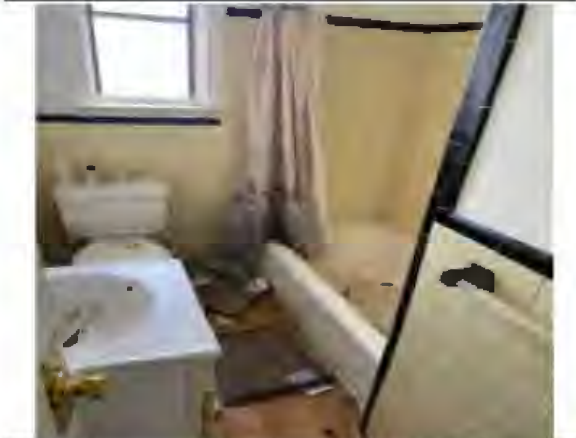
Photo #6:	Typical Bathroom Components No LBP No Elevated Lead in Ceramics
-----------	---

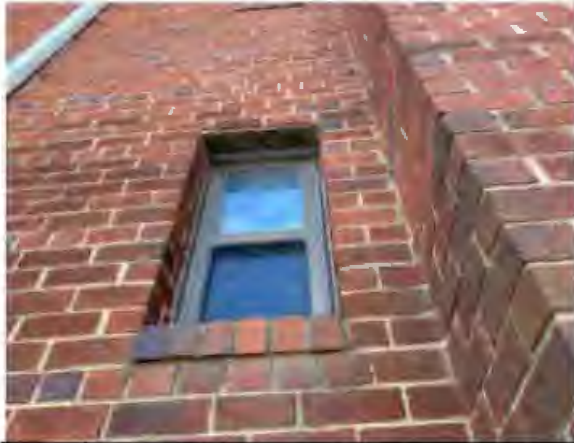
Location	Component(s)	Substrate	Color(s)
Exterior	Window Lintels	Metal	White

Photo #7:	Exterior Window Lintels LBP in Poor Condition
-----------	--

Representative waste from the demolition project should be tested for overall lead content using the TCLP methodology to determine if it should be classified as hazardous waste.

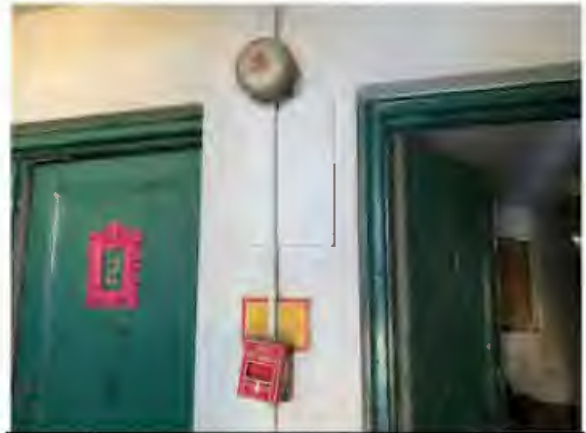
Photo #8:	Typical Hallway Components No LBP
-----------	--------------------------------------

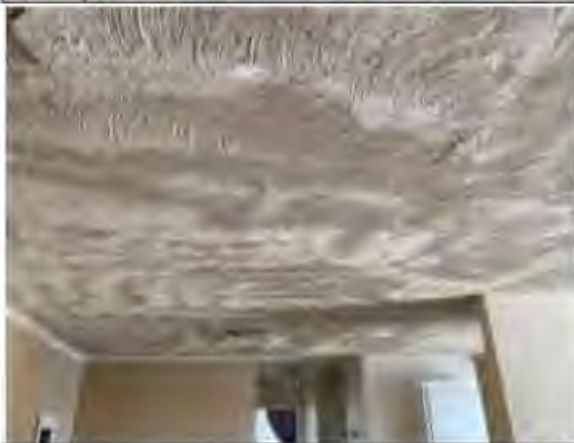
Photo #9:	Textured Ceiling Non-LBP
-----------	-----------------------------
