# *Alternative Analysis Report*

## **Rehabilitation of Bridge P-0599**

### **Governor Bridge Road over Patuxent River**

Prince George's County, Maryland

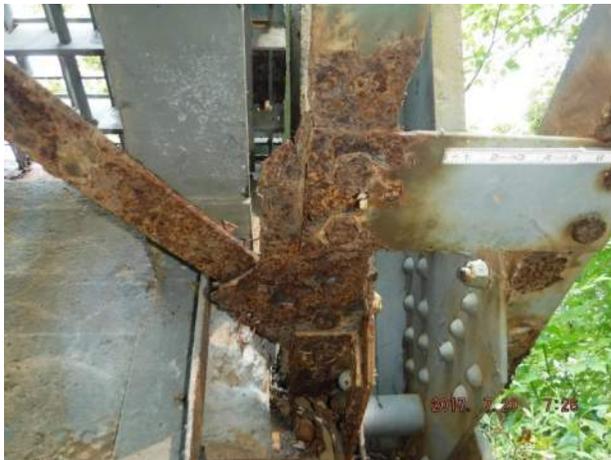
*Figure 1: Bottom Chord @ West Abutment*

In March 2015, DPW&T’s inspection staff identified significant deterioration in critical members of the bridge. If one of these critical members fails, then the whole bridge would fail catastrophically. Severe section loss with up to 100% section loss and perforations in numerous areas throughout the bridge including gusset plates, rivets and bolts, steel grid deck, inner webs, stringers, and joists were found. The bridge was closed to vehicular traffic at this time.

Superstructure: The Pratt through truss is in serious condition. The paint system is in poor condition and is failing throughout. Typically, the truss members exhibit heavy to severe corrosion at the connections, bearings, and panel points with 10%-15% section loss. The stringers exhibit area of corrosion and delaminating rust with section loss to the webs and top flange. Typically the tops of the top flanges and webs of the floorbeams are moderately corroded and pitted with up to 15% section loss. The condition rating for the bridge superstructure was 3.

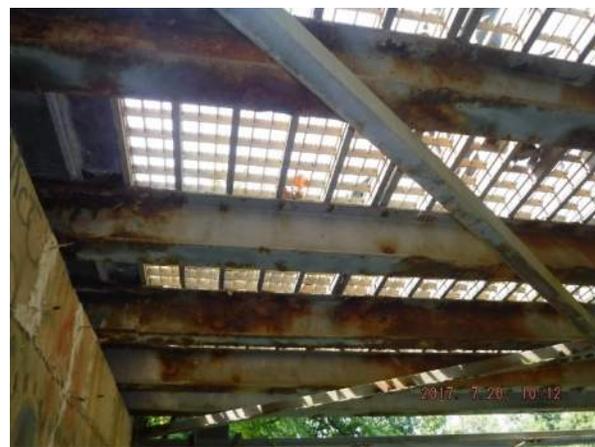
*Figure 2: Corrosion and Section Loss – Stringers*

Deck: The steel grid deck is in poor condition. There are multiple locations of severe corrosion, delaminations, and corrosion holes in the longitudinal, transverse, and joist bars throughout. The condition rating for the bridge deck was 4.

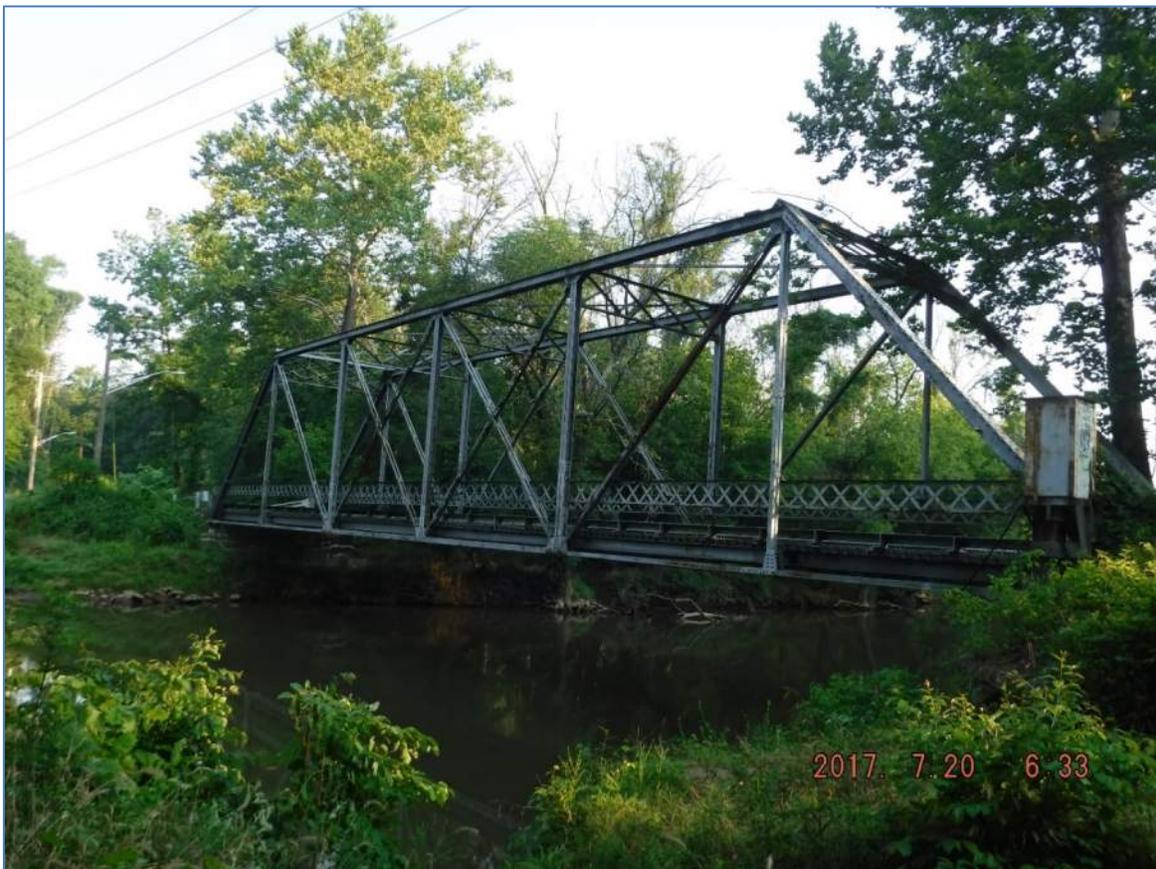
*Photo: South Elevation of Governor Bridge Road Bridge*

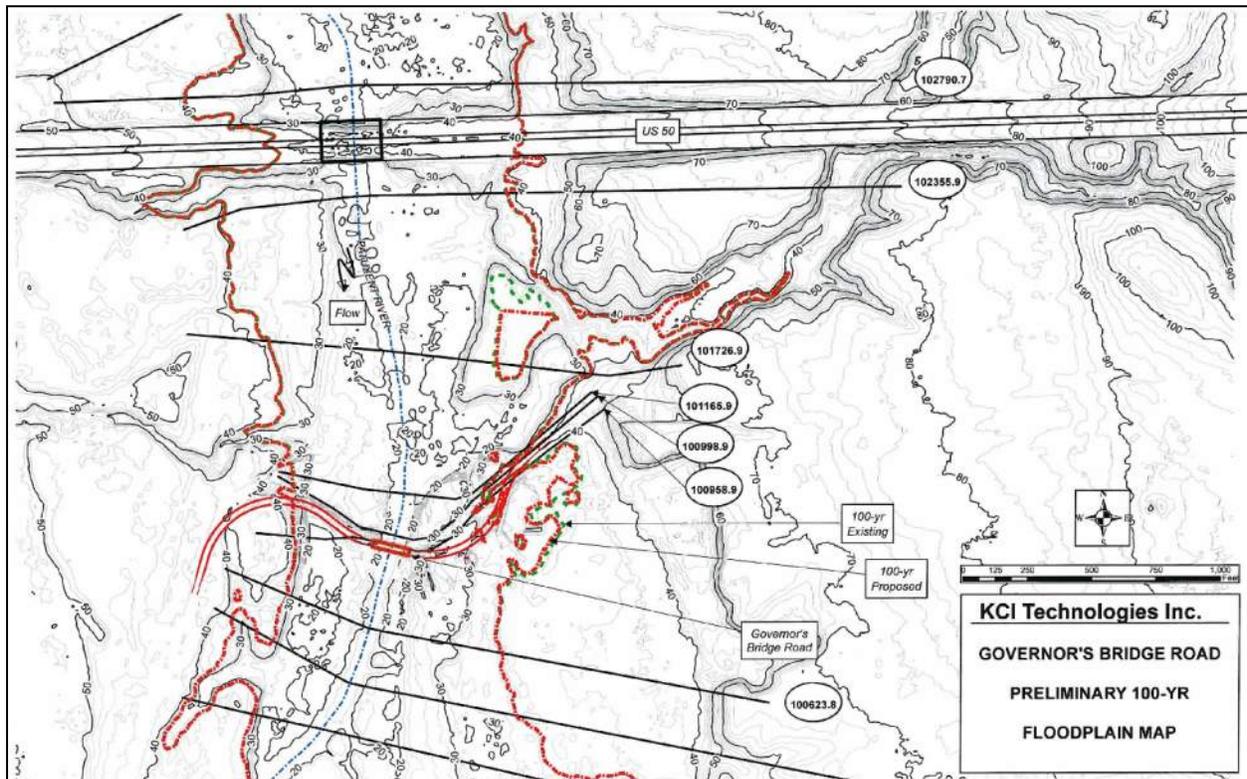
*100 Year Floodplain Map*

For the proposed conditions HEC-RAS plan, Alternative 4 was modeled since it will provide the greatest potential for floodplain impacts. (Alternative 6 would be similar to Alternative 4 with respect to floodplain impacts.) To improve hydraulic capacity, raising the profile of Governor Bridge Road on the Prince George’s County side is necessary. Constraints to the project include limiting 100-year increases to facilitate FEMA requirements since the Patuxent River is a regulated FEMA floodplain and floodway. With respect to FEMA regulations, the presence of

With respect to impacts to the upstream MDOT US 50 Bridge, this bridge is overtopped for the existing 100-year storm. The proposed Governor Bridge Road profile will only result in a slight increase in the 100-year water surface elevation of 0.17 foot at US 50. The assumption is that MDOT would accept this type of increase since the bridge overtops under existing conditions for the 100-year storm and this project would not noticeably worsen the condition. However, this would need to be verified with MDOT during the design phase of this project. There are no improved properties in the floodplain in the vicinity of Governor Bridge Road other than MDOT's US 50. COMAR requirements are expected to be met since 100-year increases are less than 0.5-foot, which would simply require notification for any impacted unimproved private properties. The 10-year comparison shows increases in excess of 1.0-foot, due to the raising of the roadway on the Prince George's County approach. However, these increases are expected to be on unimproved Prince George's County and Anne Arundel County property, such that flood mitigation measures would not be necessary to obtain MDE approval. Finally, considering the magnitude of the 100-year increase upstream of Governor Bridge Road, and with MDOT acceptance of the small 100-year increase at US 50 and the fact that there are no insurable structures impacted, eventual CLOMR approval from FEMA under the design phase of the project can be expected. Due to the potential for Federal funding for the design phase of this project, a detailed scour analysis may eventually be required for review by the counties and MDOT SHA. Appendix 15.7 provides comparisons of existing versus proposed water-surface elevation and channel velocity for the 2-, 10- and 100-year events and channel shear stress for the 2- and 10-year events, as required by COMAR.

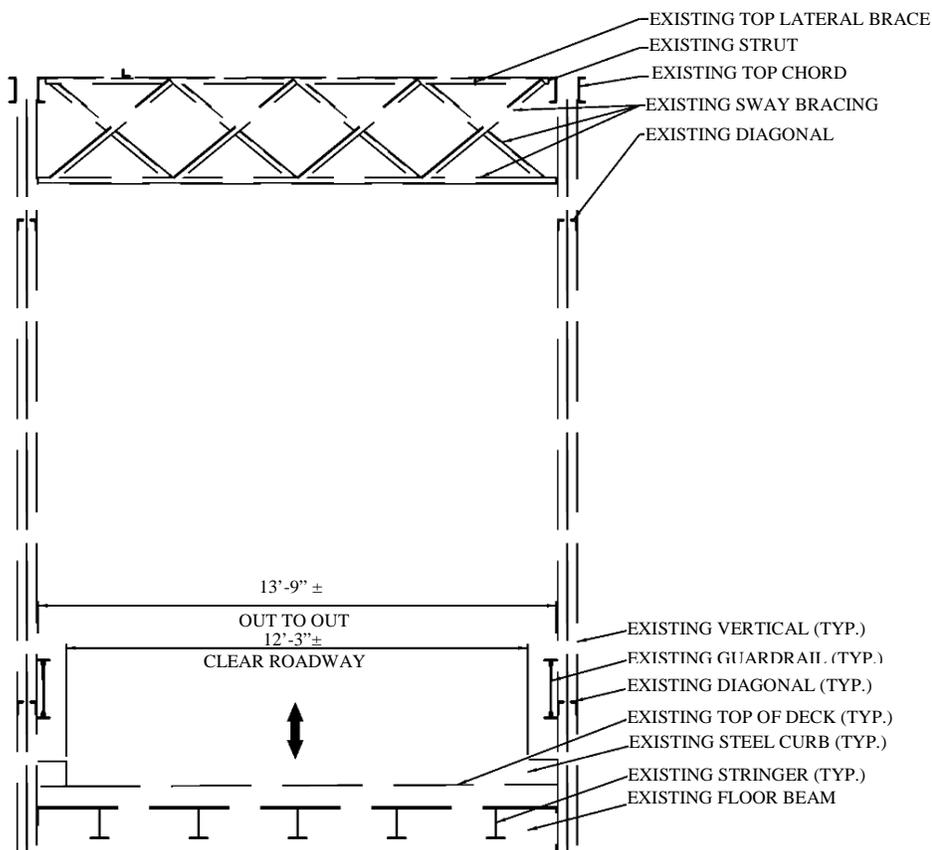
Alternative 1 - Existing Typical Section

**Alternative 1** is the least comprehensive design, whereas we do nothing. This includes no rehabilitation to the existing Pratt truss bridge and the roadway and bridge remains closed to traffic. The bridge is structurally deficient due to severe corrosion and section loss of the primary structural steel members, particularly the bottom chord members in the vicinity of the abutments. If nothing is done to structurally repair the existing bridge Governor Bridge Road will remain closed indefinitely.

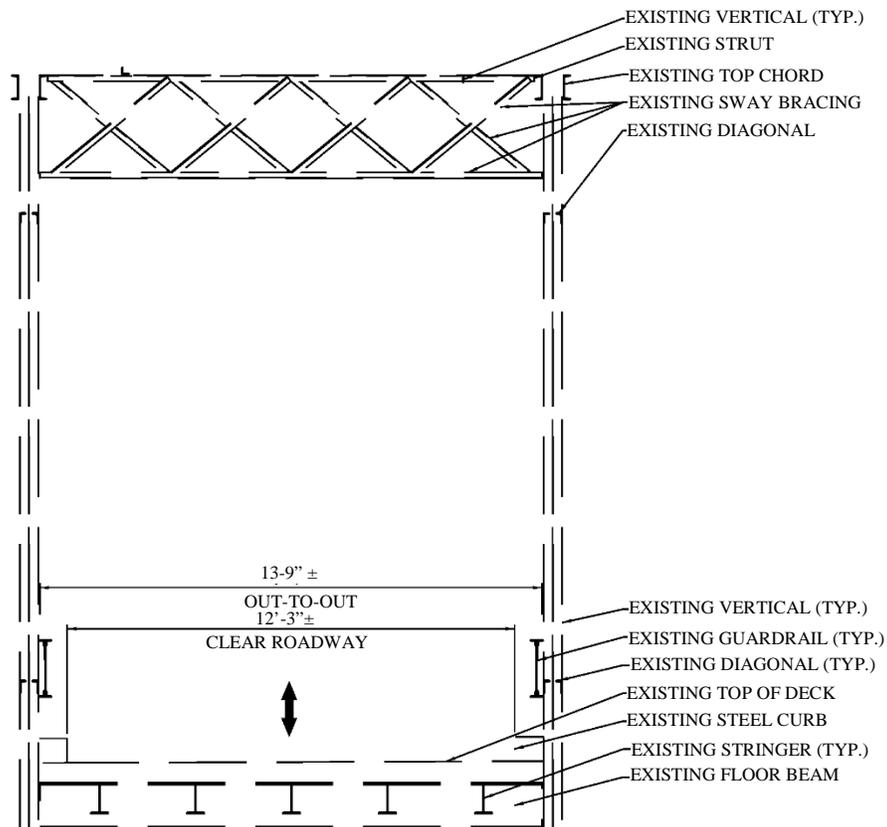
Alternative 2 Typical Section

**Alternative 2** is the minimization alternative. The existing Pratt truss bridge will be rehabilitated with little affects to its historic integrity. Besides cleaning and painting the existing bridge, the following structural members will need to be replaced: three steel stringers; nine steel bottom chords; and the steel open-grid deck. Even with the repairs, the rehabilitated bridge will remain posted for certain live loading combinations due to its inherent structural makeup. This bridge has been rehabilitated similarly in the past, most recently in 2014. Even with the repairs, the structure has undergone more deterioration and section loss in some of the primary structural steel members and was subsequently closed to vehicular traffic in March 2015. The structure remains closed as of the timing of this report. This alternative will not resolve frequent flooding on the Prince George’s County roadway approach to the bridge.

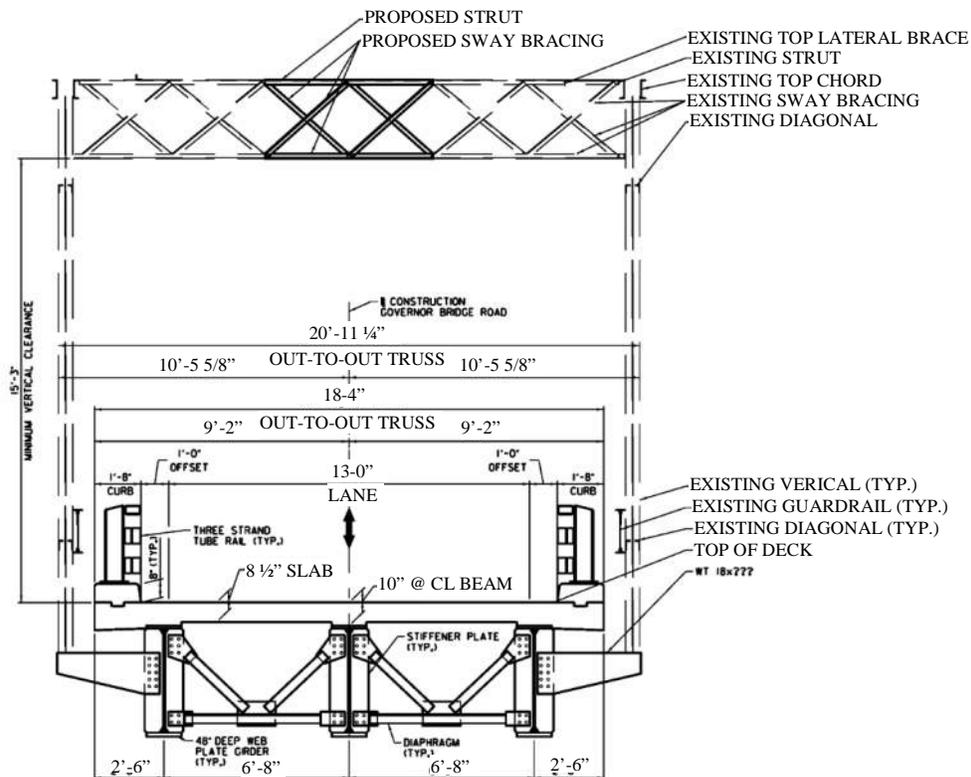
Alternative 3 Typical Section

**Alternative 3** is the least comprehensive design, providing a 15' clear roadway, one lane bridge on the existing bridge location with retained elements of the original structure. The existing Pratt truss bridge would be replaced with a steel I-girder structure and composite 8.5" thick reinforced concrete slab. Traffic barriers on the bridge will consist of a 42" high, three strand steel tube rail system. The bridge deck will be supported by three I-girders, 48" deep and spaced at 6'-8" on center. The trusses from the original bridge will be removed, retained and reinstalled only to maintain the historic appearance without providing any structural support to the bridge. Damaged portions of the existing trusses will be repaired or replaced as necessary for reuse. The existing top lateral bracing, struts and sway bracings will be cut and new members will be added to account for the slight adjustment in bridge width. The new reinforced concrete bridge abutments will be situated 10'± behind the existing bridge abutments, providing a new bridge length of 137'. The new abutments will be founded on steel piling. The existing bridge abutments will be retained to act as a stream diversion device for construction, provide scour protection for the new bridge abutments and to support the retained trusses. The steel I-girders for the new bridge will span between the new abutments, however a notch will be made within the existing abutments to allow the new girders to pass over them. Since the bridge will be designed using the latest AASHTO design criteria, there will be no live load posting for the new bridge. The profile of the new bridge will be set to clear a 2 year storm at elevation. The approaches will be raised to pass the 2-year storm. Large storm events were evaluated, but the blockage create impacts to the floodplain by more than 1' causing in impact upstream at the US50 crossing.

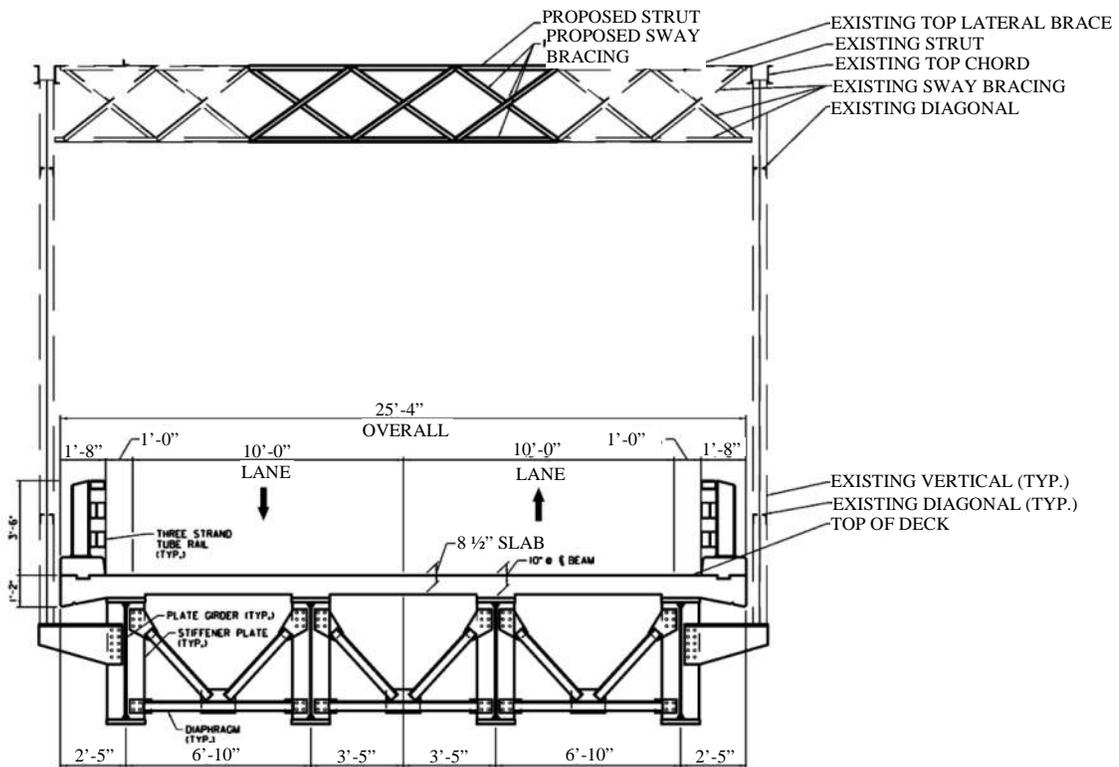
Alternative 4 Typical Section

**Alternative 4** is a moderate improvement providing a 22' clear roadway, two-lane bridge on the existing bridge location with retained elements of the original structure. Alternative 4 is similar to Alternative 3 other than the number and width of the lanes on the bridge. The existing Pratt truss bridge would be replaced with a steel I-girder structure and composite 8.5" thick reinforced concrete slab. Traffic barriers on the bridge will consist of a 42" high, three strand steel tube rail system. The bridge deck will be supported by four I-girders, 57" deep and spaced at 6'-10" on center. The trusses from the original bridge will be removed, retained and reinstalled only to maintain the historic appearance without providing any structural support to the bridge. Damaged portions of the existing trusses will be repaired or replaced as necessary for reuse. The existing top lateral bracing, struts and sway bracings will be cut and new members will be added to account for the adjustment in bridge width. The new reinforced concrete bridge abutments will sit 10'± behind the existing bridge abutments, providing a new bridge length of 137'. The new abutments will be founded on steel piling. The existing bridge abutments will be retained to act as a stream diversion device for construction, provide scour protection for the new bridge abutments and to support the retained trusses. The steel I-girders for the new bridge will span between the new abutments, however a notch will be made within the existing abutments to allow the new girders to pass through them. Since the bridge will be designed using the latest AASHTO design criteria, there will be no live load posting for the new bridge.

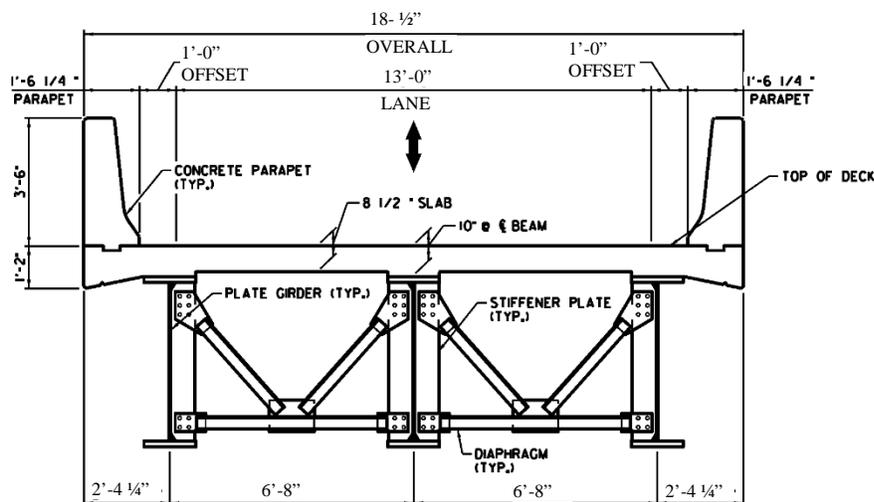
Alternative 5 Typical Section

**Alternative 5** is the avoidance alternative. It achieves the project objectives by creating a new 15' clear roadway, one-lane bridge downstream of the existing location to maintain the existing structure in the event MHT does not allow for the historical bridge to be replaced. Because this alternative constructs a new bridge at a different location, no repairs will be performed on the existing Pratt truss bridge and roadway tie-ins to the existing bridge will be removed. The new bridge will be a steel I-girder structure and composite 8.5" thick reinforced concrete slab. Traffic barriers on the bridge will be 42" high reinforced concrete parapets. The bridge deck will be supported by three I-girders, 48" deep and spaced at 6'-8" on center. The new reinforced concrete bridge abutments will be situated on the stream banks, providing a new bridge length of 137'. The new abutments will be founded on steel piling. With this alternative, the use of temporary sheeting will be needed for the construction of the abutments, which correlates to stream impacts that will need to be permitted. The new abutments will be susceptible to scour and protection, possibly through the use of riprap and longer abutment piling. Since the bridge will be designed using the latest AASHTO design criteria, there will be no live load posting for the new bridge.

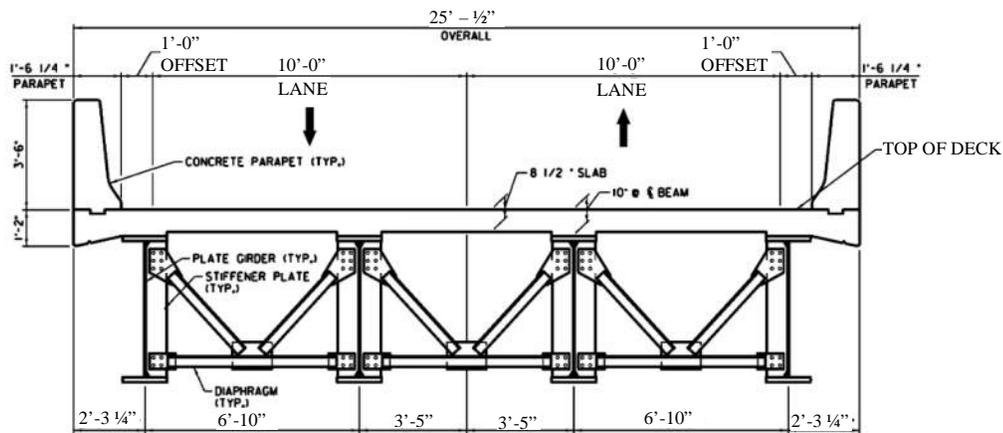
Alternative 6 Typical Section

**Alternative 6** is the avoidance alternative. It achieves the project objectives by creating a new 22' clear roadway, two-lane bridge downstream of the existing location. Because this alternative constructs a new bridge at a different location, no repairs will be performed on the existing Pratt truss bridge and roadway tie-ins to the existing bridge will be removed. Alternative 6 is similar to Alternative 5 other than the number and width of the lanes on the bridge. The new bridge will be a steel I-girder structure and composite 8.5" thick reinforced concrete slab. Traffic barriers on the bridge will be 42" high reinforced concrete parapets. The bridge deck will be supported by three I-girders, 57" deep and spaced at 6'-10" on center. The new reinforced concrete bridge abutments will be situated on the stream banks, providing a new bridge length of 137'. The new abutments will be founded on steel piling. With this alternative, the use of temporary sheeting will be needed for the construction of the abutments, which correlates to stream impacts that will need to be permitted. The new abutments will be susceptible to scour and protection, possibly through the use of riprap and longer abutment piling. Since the bridge will be designed using the latest AASHTO design criteria, there will be no live load posting for the new bridge.

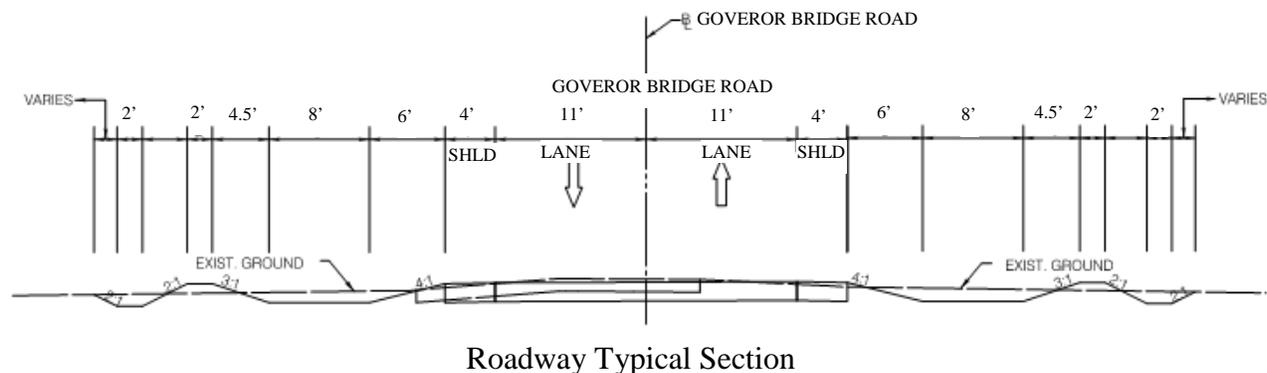
Proposed roadway improvements for each alternative will include design improvements to meet or exceed Prince George's County and Anne Arundel County design standards, where possible. As mentioned in the existing conditions, the road is considered a Rural Secondary Residential roadway. Therefore, our proposed typical section will meet Prince George's County Std. 100.11. Proposed improvements include an open section roadway with two - 11 foot lanes and 4 foot shoulder on each side of the roadway. As shown in Table I-2 Design Criteria in Prince George's County Department of Public Works and Transportation Guide and AASHTO, a 30 MPH design speed is utilized with a minimum curve radius of 300 feet, and a 10% centerline grade maximum with a 50' Right-of-Way. Superelevation for all alternatives is normal crown, using ASSHTO method 2. The proposed roadway typical section is shown below.

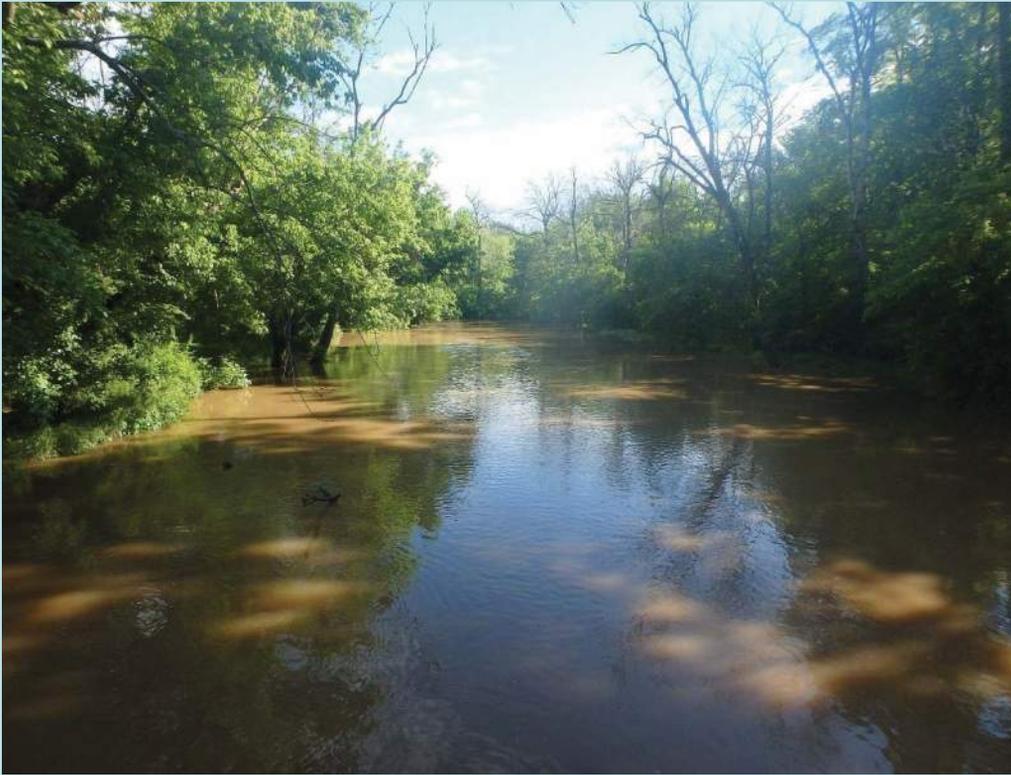
Comments: View of WUS

WL001 facing upstream from  
bridge.

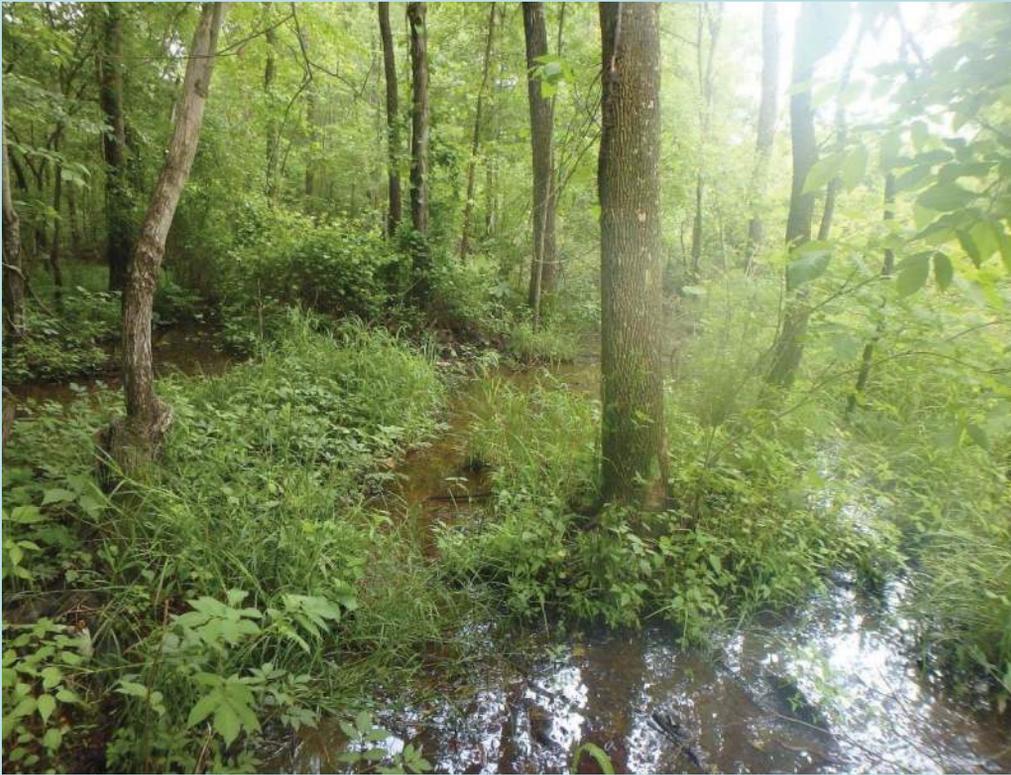
Photographer: K. Myers  
Date: 5/26/2017  
Frame No. 3  
Direction: West  
Comments: View of Wetland  
Sample Plot WL002-WET.

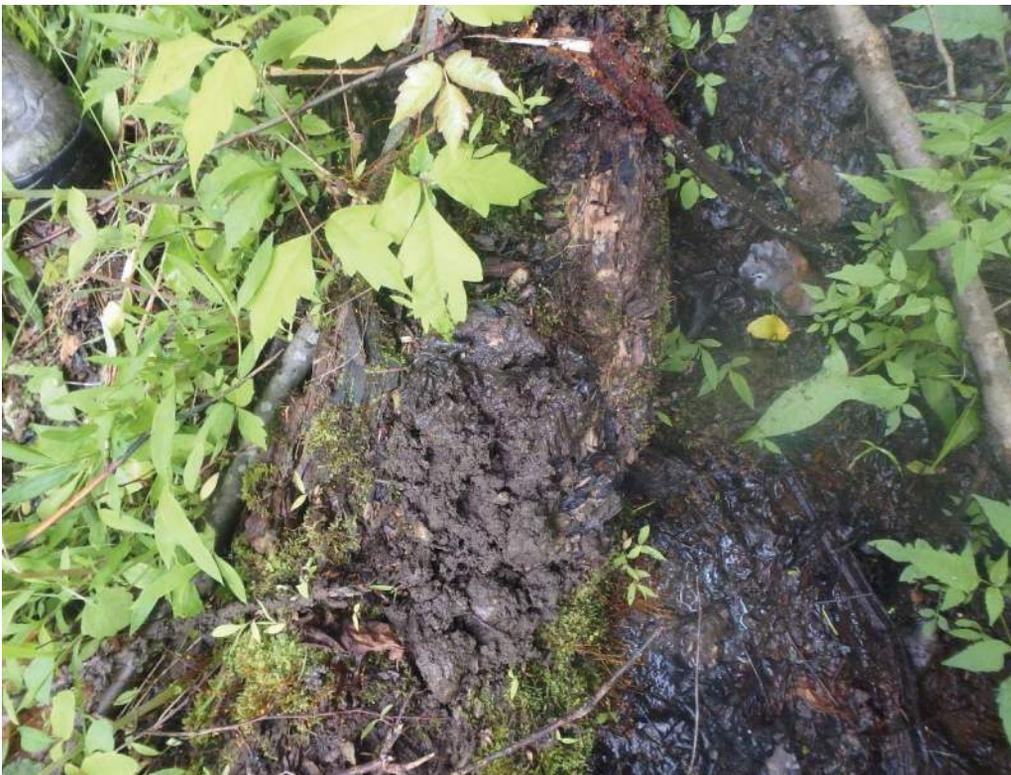
Photographer: K. Myers  
Date: 5/26/2017  
Frame No. 4  
Direction: N/A  
Comments: View of Wetland  
Sample Plot WL002-WET soils.

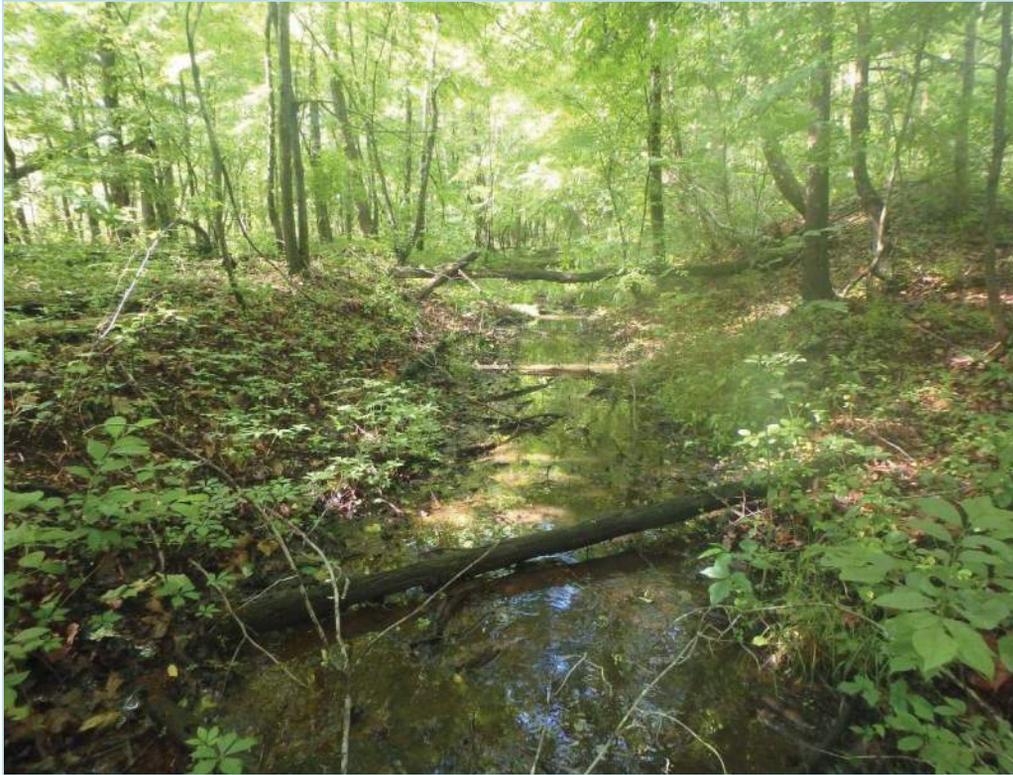
Photographer: K. Myers  
Date: 5/26/2017  
Frame No. 5  
Direction: Southwest  
Comments: View of WUS  
WL003 facing downstream from  
flag WL003-005.

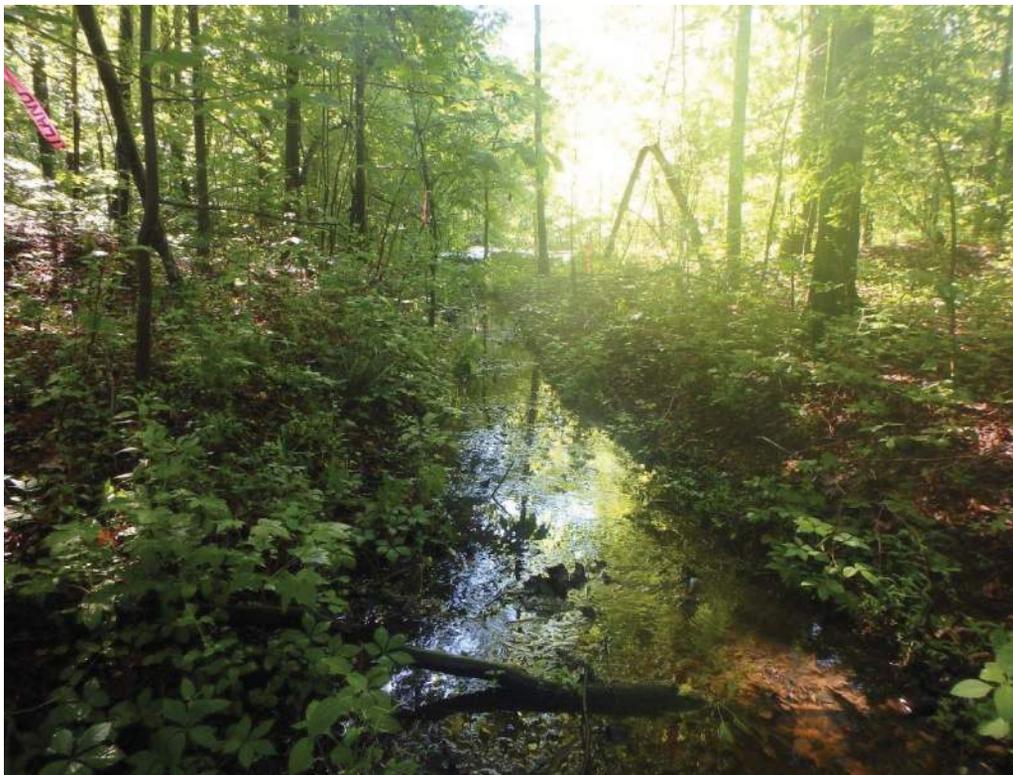
Photographer: K. Myers  
Date: 5/26/2017  
Frame No. 6  
Direction: East  
Comments: View of WUS  
WL004 facing upstream from  
flag WL004-002.

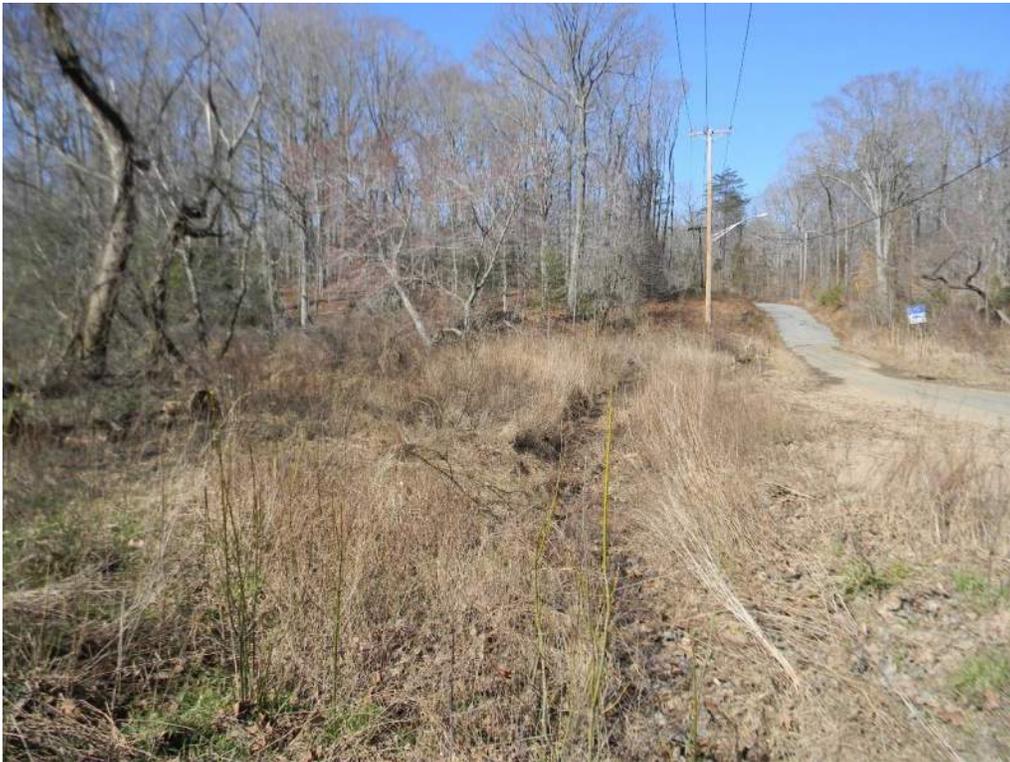
**Photo 4** – Area of high velocity flooding in SW quadrant, view facing NW

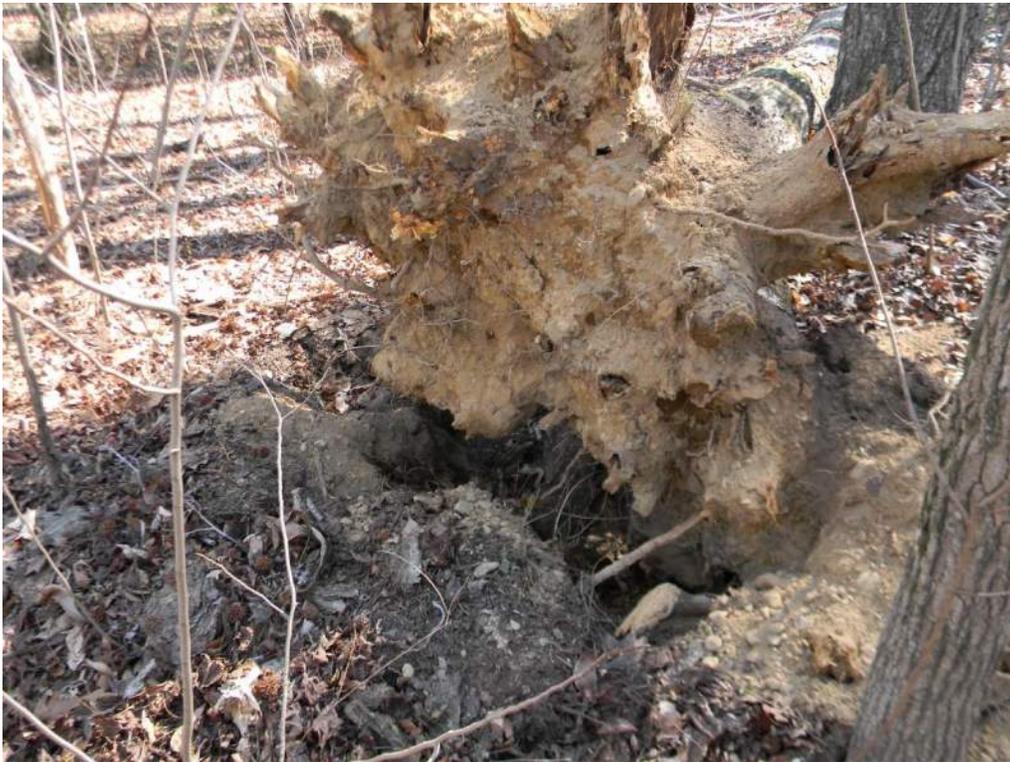
**Photo 5** – Treefall in SW quadrant, illustrating percentage of quartz cobbles within soil matrix, view facing N/NW

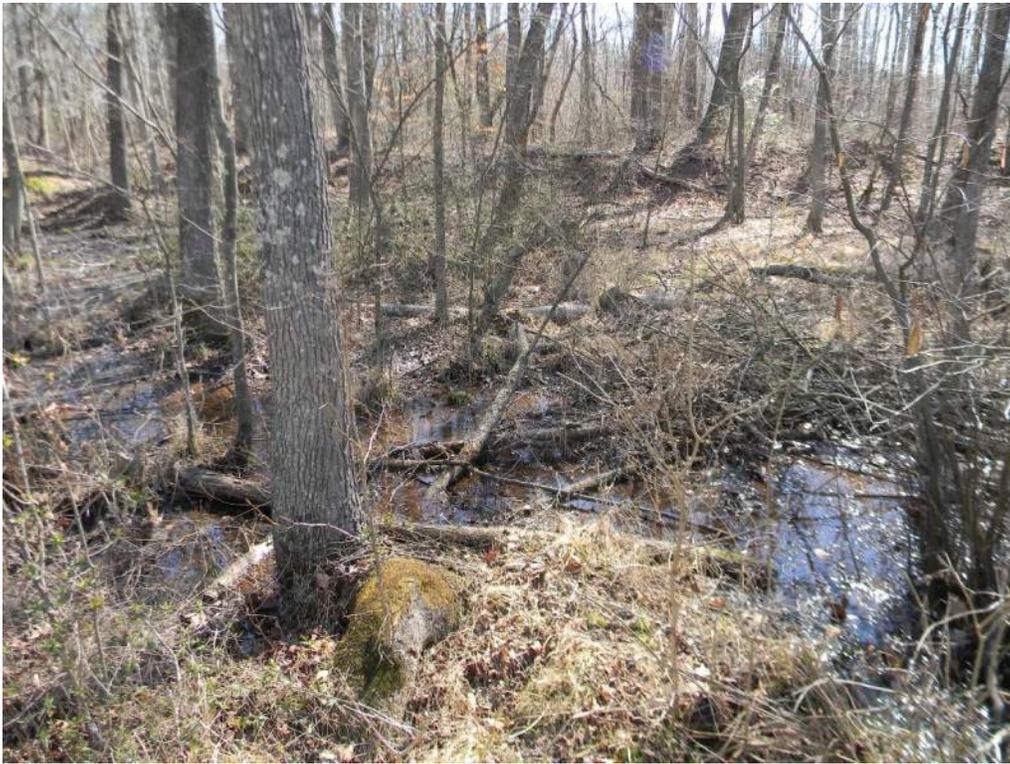
**Photo 8** – View of SE illustrating wet and boggy conditions, view facing E

The southeastern quadrant is located on a poorly drained floodplain and terrace setting between the Patuxent River and the adjacent uplands. This quadrant exhibits numerous pools of standing water, small streams, ditches and generally boggy conditions. In addition, several large spoils piles dot the setting within the quadrant (**Photos 8 and 9**). In several locales these spoils piles appear to be associated with excavation of the ditches and streams, or construction of the extant roadway. Given the poorly drained setting and evidence of disturbance, no subsurface investigation was conducted within the southeastern quadrant of the APE.

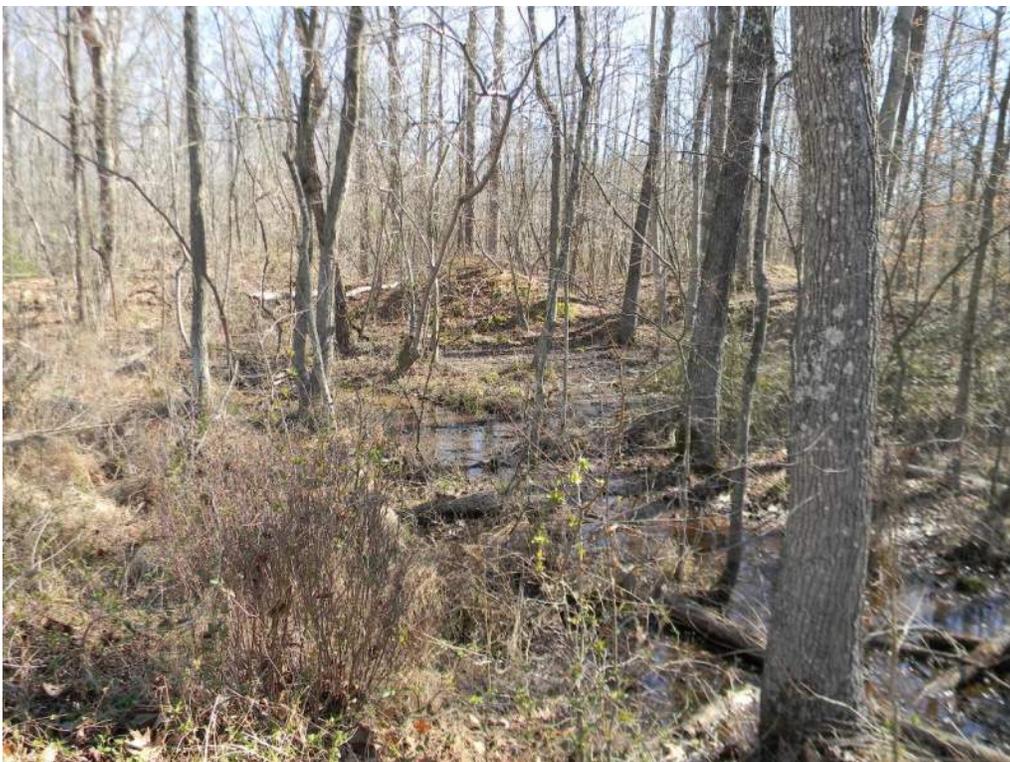
**Photo 9** – View of SE quadrant illustrating wet conditions and push piles, view facing E/NE

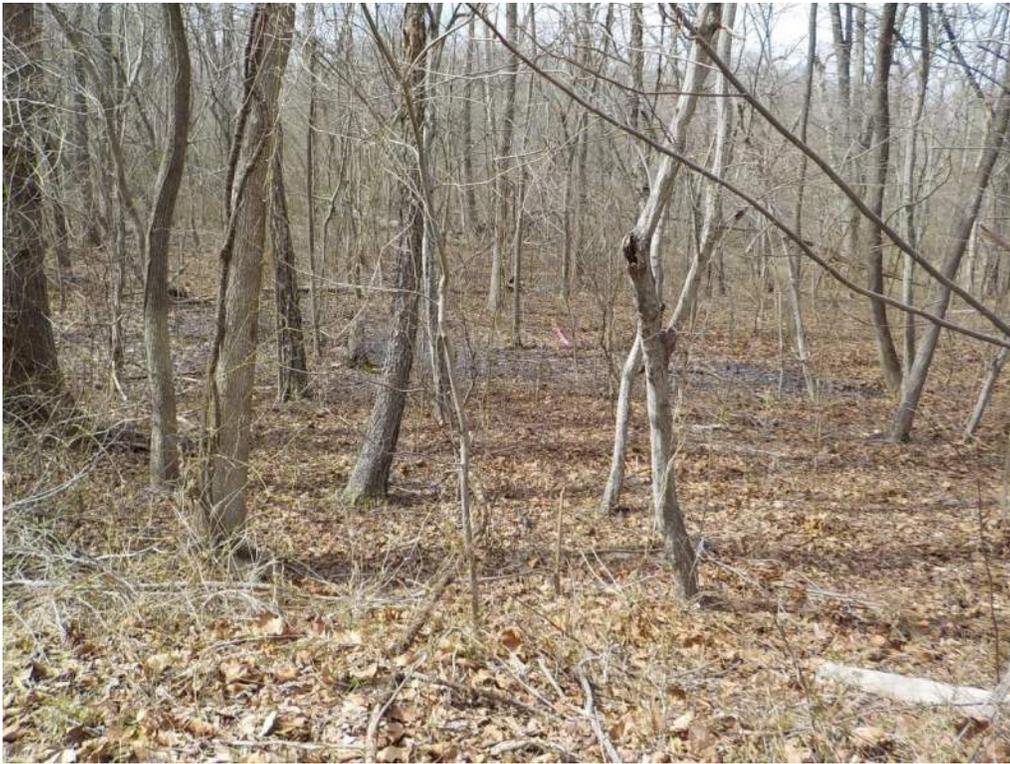
**Photo 12** – View of poorly drained area in floodplain of NE quadrant, view facing N

The northeastern quadrant of the APE is situated on a similar topographic setting as noted in the southeastern quadrant. The eastern end of the quadrant consists of a narrow, 12 to 18 m-wide flat terrace setting overlooking the Patuxent River floodplain (**Photo 10**). A steep slope forms the northwestern boundary of the terrace and delineates the topographic transition to the floodplain. Evidence of ground disturbance, including large pits and push piles, dot the setting in the northeastern quadrant. A mix of auto parts, household debris, and other trash was observed in association with the pits and push piles, as well as scattered throughout the quadrant (**Photo 11**). A road cut leads north from the extant roadway through the quadrant and down to the floodplain. The terrace narrows towards the southwest, eventually tapering into the extant roadway approximately 90m east of the bridge. The setting transitions to a wooded, poorly drained floodplain with numerous pools of standing water and evidence of scour (**Photo 12**).

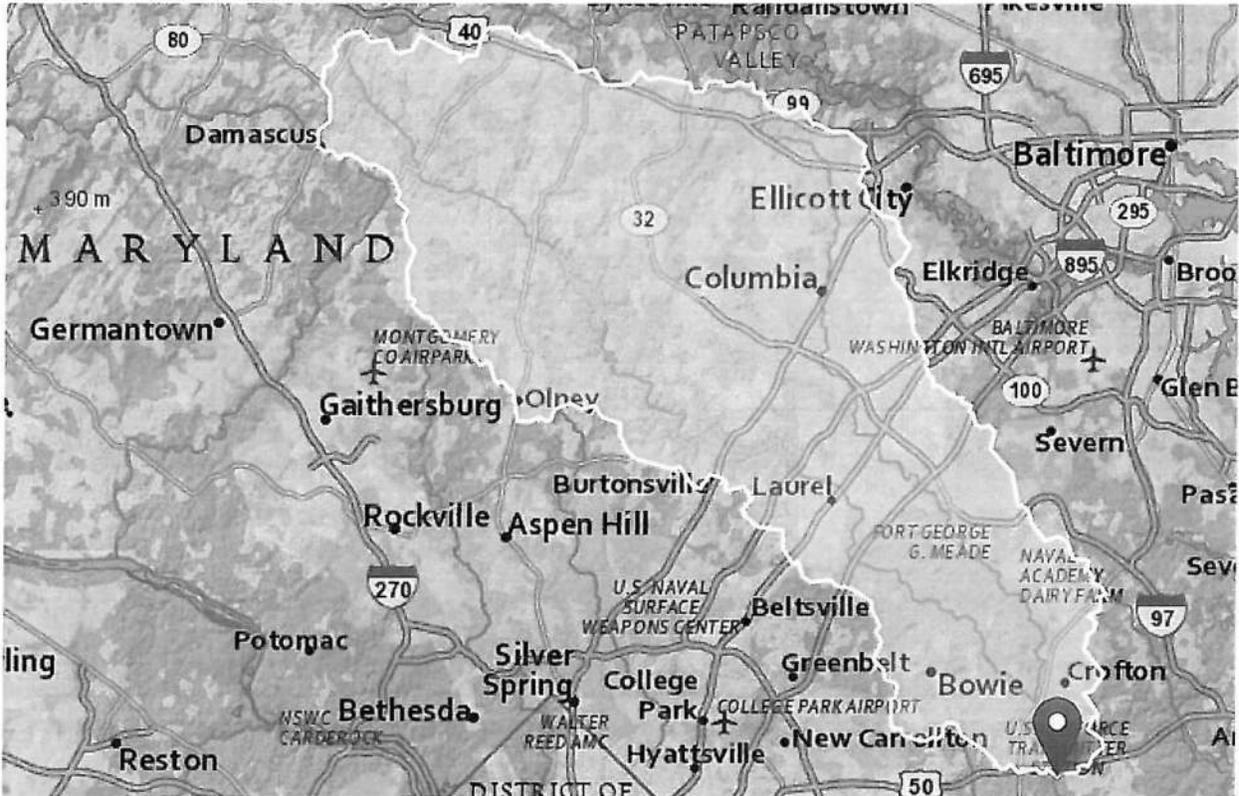
# StreamStats Report

Region ID: MD  
 Workspace ID: MD20180118143435603000  
 Clicked Point (Latitude, Longitude): 38.95140, -76.69333  
 Time: 2018-01-18 09:33:53 -0500
